Access Compliance Report Public Rights-of-Way (Island Curb Cuts)

Intersection ID: 27942 Main Street: COMMUNITY_HOUSE_RD Cross Street: NORTH_COMMUNITY_HOUSE_RD Location: NW

ADA ID: FCAFCE6A6FFB Curb Cut Type: MedianRefuge2 Initial Pass/Fail: Fail Overall Compliance: No Severity Score: 12.5

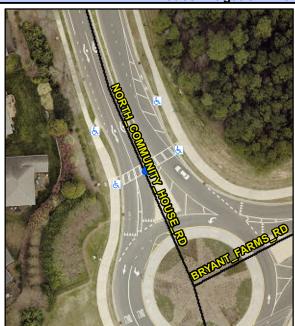
No	Refuge 1 Length (In)	23.0	N/A	Gutter 1 Ponding?	N/A
Yes	Refuge 1 Width (In)	114.0	N/A	Gutter 1 Lip Ht (In)	N/A
No	Refuge 1 Slope (%)	5.3	N/A	Gutter 1 Slope (%)	N/A
Yes	Refuge 1 X Slope (%)	2.6	N/A	Gutter 1 X Slope (%)	N/A
N/A	Painted X Walk1?	Yes	N/A	DWS 1 Provided?	N/A
N/A	X Walk 1 Direction	To NE	N/A	DWS 1 Contrast?	N/A
N/A	X Walk 1 Width (In)	108.0	N/A	DWS 1 Length (In)	N/A
N/A	Road 1 Slope (%)	2.2	N/A	DWS 1 Full Width?	N/A
N/A	Road 1 X Slope (%)	2.1	N/A	DWS 1 Offset (In)	N/A
No	Refuge 2 Length (In)	23.0	N/A	Gutter 2 Ponding?	N/A
Yes	Refuge 2 Width (In)	114.0	N/A	Gutter 2 Lip Ht (In)	N/A
Yes	Refuge 2 Slope (%)	4.6	N/A	Gutter 2 Slope (%)	N/A
Yes	Refuge 2 X Slope (%)	2.2	N/A	Gutter 2 X Slope (%)	N/A
N/A	Painted X Walk2?	Yes	N/A	DWS 2 Provided?	N/A
N/A	X Walk 2 Direction	To SW	N/A	DWS 2 Contrast?	N/A
N/A	X Walk 2 Width (In)	109.0	N/A	DWS 2 Length (In)	N/A
N/A	Road 2 Slope (%)	1.1	N/A	DWS 2 Full Width?	N/A

Remove & Replace Entire Refuge.
