Access Compliance Report

Public Rights-of-Way

(Island Curb Cuts)

Intersection ID: 47611	Main Street: WYALONG_DR	Cross Street: MINTWORTH_AV	Location: SE
ADA ID: FD3D619AEA1C	Curb Cut Type: MedianRefuge2	Initial Pass/Fail: Fail	Overall Compliance: No
Codes/Mitigation Info/Possible Solution		Field Measurements/Component Compliance	
Severity Score: 8.75

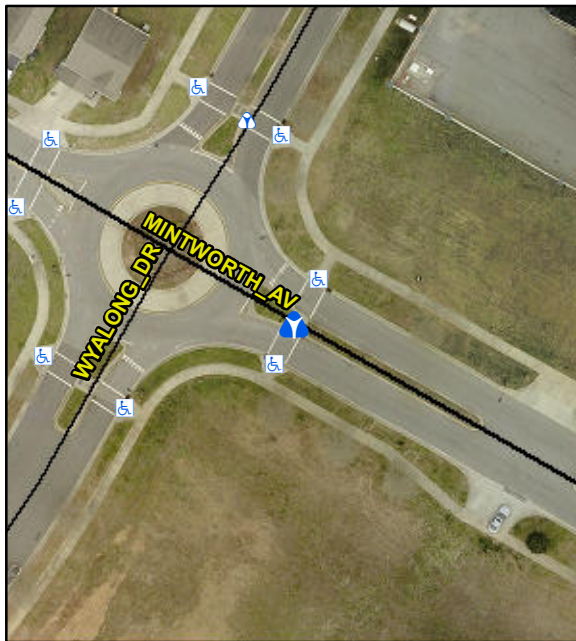
Compliance	Description	Data	Compliance	Description	Data
Yes	Refuge 1 Length (In)	44.5	N/A	Gutter 1 Ponding?	N/A
No	Refuge 1 Width (In)	48.0	N/A	Gutter 1 Lip Ht (In)	N/A
Yes	Refuge 1 Slope (%)	1.9	N/A	Gutter 1 Slope (%)	N/A
Yes	Refuge 1 X Slope (%)	5.0	N/A	Gutter 1 X Slope (%)	N/A
N/A	Painted X Walk1?	Yes	N/A	DWS 1 Provided?	N/A
N/A	X Walk 1 Direction	To SW	N/A	DWS 1 Contrast?	N/A
N/A	X Walk 1 Width (In)	119.0	N/A	DWS 1 Length (In)	N/A
N/A	Road 1 Slope (%)	2.3	N/A	DWS 1 Full Width?	N/A
N/A	Road 1 X Slope (%)	1.3	N/A	DWS 1 Offset (In)	N/A
Yes	Refuge 2 Length (In)	44.5	N/A	Gutter 2 Ponding?	N/A
No	Refuge 2 Width (In)	48.0	N/A	Gutter 2 Lip Ht (In)	N/A
Yes	Refuge 2 Slope (%)	0.6	N/A	Gutter 2 Slope (%)	N/A
Yes	Refuge 2 X Slope (%)	3.6	N/A	Gutter 2 X Slope (%)	N/A
N/A	Painted X Walk2?	Yes	N/A	DWS 2 Provided?	N/A
N/A	X Walk 2 Direction	To NE	N/A	DWS 2 Contrast?	N/A
N/A	X Walk 2 Width (In)	120.0	N/A	DWS 2 Length (In)	N/A

Remove & Replace Entire Refuge.
