Access Compliance Report Public Rights-of-Way (Island Curb Cuts)

Intersection ID: 10025446	Main Street: E_INDEPENDENCE_BV	Cross Street: N/A	Location: E
ADA ID: FE8111C1248B	Curb Cut Type: MedianRefuge2	Initial Pass/Fail: Pass	Overall Compliance: No Severity Score: 15

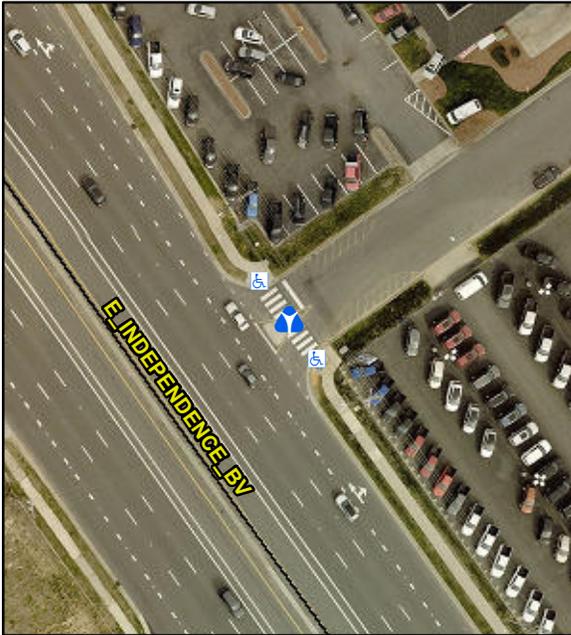
Compliance	Description	Data	Compliance	Description	Data
No	Refuge 1 Length (In)	27.0	Yes	Gutter 1 Ponding?	No
Yes	Refuge 1 Width (In)	74.0	Yes	Gutter 1 Lip Ht (In)	0.0
Yes	Refuge 1 Slope (%)	0.4	Yes	Gutter 1 Slope (%)	3.6
Yes	Refuge 1 X Slope (%)	0.3	No	Gutter 1 X Slope (%)	2.2
N/A	Painted X Walk1?	Yes	Yes	DWS 1 Provided?	No
N/A	X Walk 1 Direction	To NW	N/A	DWS 1 Contrast?	N/A
N/A	X Walk 1 Width (In)	119.5	N/A	DWS 1 Length (In)	N/A
N/A	Road 1 Slope (%)	0.6	N/A	DWS 1 Full Width?	N/A
N/A	Road 1 X Slope (%)	1.1	N/A	DWS 1 Offset (In)	N/A
No	Refuge 2 Length (In)	27.0	Yes	Gutter 2 Ponding?	No
Yes	Refuge 2 Width (In)	74.0	Yes	Gutter 2 Lip Ht (In)	0.0
Yes	Refuge 2 Slope (%)	0.6	Yes	Gutter 2 Slope (%)	3.0
Yes	Refuge 2 X Slope (%)	1.6	Yes	Gutter 2 X Slope (%)	1.3
N/A	Painted X Walk2?	Yes	Yes	DWS 2 Provided?	No
N/A	X Walk 2 Direction	To SE	N/A	DWS 2 Contrast?	N/A
N/A	X Walk 2 Width (In)	119.0	N/A	DWS 2 Length (In)	N/A

N/A	Road 2 Slope (%)	1.0	N/A	DWS 2 Full Width?	N/A
N/A	Road 2 X Slope (%)	1.1	N/A	DWS 2 Offset (In)	N/A
N/A	Refuge 3 Length (in)	N/A	N/A	Gutter 3 Ponding?	N/A
N/A	Refuge 3 Width (in)	N/A	N/A	Gutter 3 Lip Ht (in)	N/A
N/A	Refuge 3 Slope (%)	N/A	N/A	Gutter 3 Slope (%)	N/A
N/A	Refuge 3 XSlope (%)	N/A	N/A	Gutter 3 XSlope (%)	N/A
N/A	Painted X Walk3?	N/A	N/A	DWS 3 Provided?	N/A
N/A	X Walk 3 Direction	N/A	N/A	DWS 3 Contrast?	N/A
N/A	X Walk 3 Width (in)	N/A	N/A	DWS 3 Length (in)	N/A
N/A	Road 3 Slope (%)	N/A	N/A	DWS 3 Full Width?	N/A
N/A	Road 3 XSlope (%)	N/A	N/A	DWS 3 Offset (in)	N/A
Yes	Any Obstructions?	N/A	N/A	Storm Grate/Utility Hazard?	No
N/A	Obstruction Type		N/A	Storm Grate/Utility Type	
			N/A		N/A
N/A	Surface Condition	Good

Possible Solutions:
**Remove & Replace Entire Refuge.
Remove & Replace Gutter.**

Total Cost: \$ **3750.00**
