Access Compliance Report

Public Rights-of-Way

(Island Curb Cuts)

Intersection ID: 54269	Main Street: JOHNSTON_OEHLER_RD	Cross Street: OEHLER_BRIDGE_DR	Location: N
ADA ID: FEB9F61EBC89	Curb Cut Type: MedianRefuge2	Initial Pass/Fail: Fail	Overall Compliance: No
Severity Score: 1.25			
Codes/Mitigation Info/Possible Solution		Field Measurements/Component Compliance

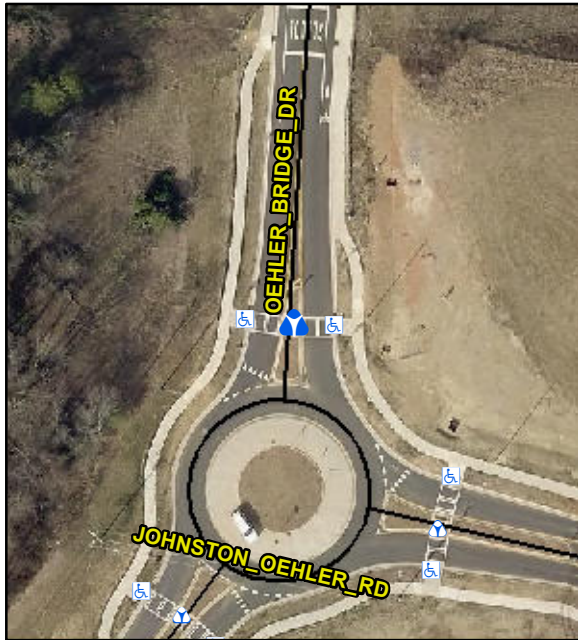
Compliance	Description	Data	Compliance	Description	Data
Yes	Refuge 1 Length (In)	42.0	N/A	Gutter 1 Ponding?	N/A
Yes	Refuge 1 Width (In)	116.0	N/A	Gutter 1 Lip Ht (In)	N/A
Yes	Refuge 1 Slope (%)	2.7	N/A	Gutter 1 Slope (%)	N/A
Yes	Refuge 1 X Slope (%)	3.7	N/A	Gutter 1 X Slope (%)	N/A
N/A	Painted X Walk1?	Yes	N/A	DWS 1 Provided?	N/A
N/A	X Walk 1 Direction	To E	N/A	DWS 1 Contrast?	N/A
N/A	X Walk 1 Width (In)	112.0	N/A	DWS 1 Length (In)	N/A
N/A	Road 1 Slope (%)	2.8	N/A	DWS 1 Full Width?	N/A
N/A	Road 1 X Slope (%)	2.7	N/A	DWS 1 Offset (In)	N/A
Yes	Refuge 2 Length (In)	42.0	N/A	Gutter 2 Ponding?	N/A
Yes	Refuge 2 Width (In)	116.0	N/A	Gutter 2 Lip Ht (In)	N/A
Yes	Refuge 2 Slope (%)	0.5	N/A	Gutter 2 Slope (%)	N/A
Yes	Refuge 2 X Slope (%)	3.4	N/A	Gutter 2 X Slope (%)	N/A
N/A	Painted X Walk2?	Yes	N/A	DWS 2 Provided?	N/A
N/A	X Walk 2 Direction	To W	N/A	DWS 2 Contrast?	N/A
N/A	X Walk 2 Width (In)	112.0	N/A	DWS 2 Length (In)	N/A

N/A	Road 2 Slope (%)	3.6	N/A	DWS 2 Full Width?	N/A
N/A	Road 2 X Slope (%)	1.8	N/A	DWS 2 Offset (In)	N/A
N/A	Refuge 3 Length (in)	N/A	N/A	Gutter 3 Ponding?	N/A
N/A	Refuge 3 Width (in)	N/A	N/A	Gutter 3 Lip Ht (in)	N/A
N/A	Refuge 3 Slope (%)	N/A	N/A	Gutter 3 Slope (%)	N/A
N/A	Refuge 3 XSlope (%)	N/A	N/A	Gutter 3 XSlope (%)	N/A
N/A	Painted X Walk3?	N/A	N/A	DWS 3 Provided?	N/A
N/A	X Walk 3 Direction	N/A	N/A	DWS 3 Contrast?	N/A
N/A	X Walk 3 Width (in)	N/A	N/A	DWS 3 Length (in)	N/A
N/A	Road 3 Slope (%)	N/A	N/A	DWS 3 Full Width?	N/A
N/A	Road 3 XSlope (%)	N/A	N/A	DWS 3 Offset (in)	N/A
Yes	Any Obstructions?	N/A	N/A	Storm Grate/Utility Hazard?	N/A
N/A	Obstruction Type		N/A	Storm Grate/Utility Type	
		N/A			N/A
N/A	Surface Condition	Good

Possible Solutions:

Remove & Replace Entire Refuge.

Total Cost: \$ 3000.00
