Access Compliance Report

Public Rights-of-Way

(Island Curb Cuts)

Intersection ID: 15201	Main Street: ALBEMARLE_RD	Cross Street: LAWYERS_RD	Location: E
ADA ID: FEC93C991C45	Curb Cut Type: MedianRefuge2	Initial Pass/Fail: Pass	Overall Compliance: No
Codes/Mitigation Info/Possible Solution		Field Measurements/Component Compliance	
		Severity Score: 5

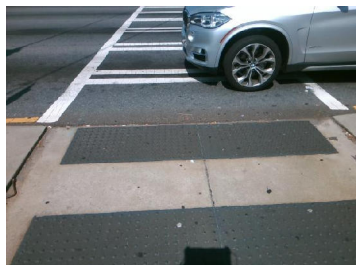
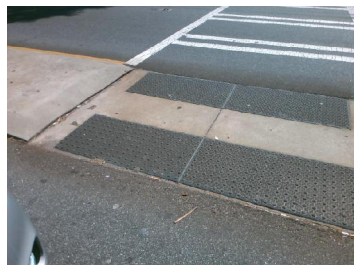
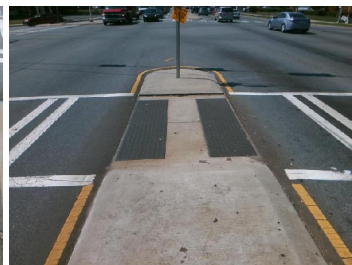
Compliance	Description	Data	Compliance	Description	Data
Yes	Refuge 1 Length (In)	36.0	Yes	Gutter 1 Ponding?	No
Yes	Refuge 1 Width (In)	118.0	Yes	Gutter 1 Lip Ht (In)	0.0
Yes	Refuge 1 Slope (%)	0.5	Yes	Gutter 1 Slope (%)	1.2
Yes	Refuge 1 X Slope (%)	1.7	Yes	Gutter 1 X Slope (%)	4.5
N/A	Painted X Walk1?	Yes	Yes	DWS 1 Provided?	Yes
N/A	X Walk 1 Direction	To N	Yes	DWS 1 Contrast?	Yes
N/A	X Walk 1 Width (In)	121.0	Yes	DWS 1 Length (In)	24.0
N/A	Road 1 Slope (%)	1.2	No	DWS 1 Full Width?	No
N/A	Road 1 X Slope (%)	4.5	Yes	DWS 1 Offset (In)	0.0
Yes	Refuge 2 Length (In)	36.0	Yes	Gutter 2 Ponding?	No
Yes	Refuge 2 Width (In)	118.0	Yes	Gutter 2 Lip Ht (In)	0.0
Yes	Refuge 2 Slope (%)	0.9	No	Gutter 2 Slope (%)	N/A
Yes	Refuge 2 X Slope (%)	1.1	No	Gutter 2 X Slope (%)	N/A
N/A	Painted X Walk2?	Yes	Yes	DWS 2 Provided?	Yes
N/A	X Walk 2 Direction	To S	Yes	DWS 2 Contrast?	Yes
N/A	X Walk 2 Width (In)	121.0	Yes	DWS 2 Length (In)	24.0

N/A	Road 2 Slope (%)	0.7	No	DWS 2 Full Width?	No
N/A	Road 2 X Slope (%)	0.7	Yes	DWS 2 Offset (In)	0.0
N/A	Refuge 3 Length (in)	N/A	N/A	Gutter 3 Ponding?	N/A
N/A	Refuge 3 Width (in)	N/A	N/A	Gutter 3 Lip Ht (in)	N/A
N/A	Refuge 3 Slope (%)	N/A	N/A	Gutter 3 Slope (%)	N/A
N/A	Refuge 3 XSlope (%)	N/A	N/A	Gutter 3 XSlope (%)	N/A
N/A	Painted X Walk3?	No	N/A	DWS 3 Provided?	N/A
N/A	X Walk 3 Direction	N/A	N/A	DWS 3 Contrast?	N/A
N/A	X Walk 3 Width (in)	N/A	N/A	DWS 3 Length (in)	N/A
N/A	Road 3 Slope (%)	N/A	N/A	DWS 3 Full Width?	N/A
N/A	Road 3 XSlope (%)	N/A	N/A	DWS 3 Offset (in)	N/A
Yes	Any Obstructions?	No	N/A	Storm Grate/Utility Hazard?	No
N/A	Obstruction Type		N/A	Storm Grate/Utility Type	
		N/A			N/A
N/A	Surface Condition	Good

Remove & Replace Detectable Warning System. Remove & Replace Gutter.
