Access Compliance Report

Public Rights-of-Way

(Island Curb Cuts)

Intersection ID: 10025446	Main Street: E_INDEPENDENCE_BV	Cross Street: N/A	Location: E
ADA ID: FEEEE3D7EC4D	Curb Cut Type: MedianRefuge2	Initial Pass/Fail: Fail	Overall Compliance: No
Codes/Mitigation Info/Possible Solution		Field Measurements/Component Compliance

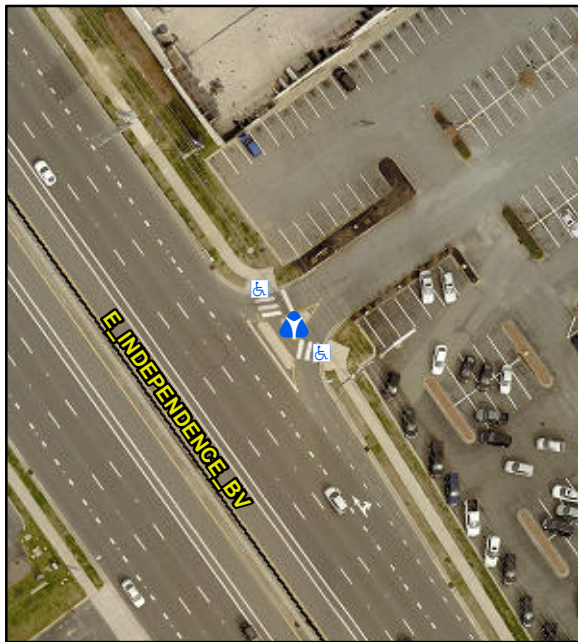
Compliance	Description	Data	Compliance	Description	Data
Yes	Refuge 1 Length (In)	80.0	N/A	Gutter 1 Ponding?	N/A
Yes	Refuge 1 Width (In)	71.0	N/A	Gutter 1 Lip Ht (In)	N/A
Yes	Refuge 1 Slope (%)	1.4	N/A	Gutter 1 Slope (%)	N/A
No	Refuge 1 X Slope (%)	8.9	N/A	Gutter 1 X Slope (%)	N/A
N/A	Painted X Walk1?	Yes	N/A	DWS 1 Provided?	N/A
N/A	X Walk 1 Direction	To SE	N/A	DWS 1 Contrast?	N/A
N/A	X Walk 1 Width (In)	126.0	N/A	DWS 1 Length (In)	N/A
N/A	Road 1 Slope (%)	10.2	N/A	DWS 1 Full Width?	N/A
N/A	Road 1 X Slope (%)	4.5	N/A	DWS 1 Offset (In)	N/A
Yes	Refuge 2 Length (In)	80.0	N/A	Gutter 2 Ponding?	N/A
Yes	Refuge 2 Width (In)	71.0	N/A	Gutter 2 Lip Ht (In)	N/A
Yes	Refuge 2 Slope (%)	1.6	N/A	Gutter 2 Slope (%)	N/A
No	Refuge 2 X Slope (%)	9.9	N/A	Gutter 2 X Slope (%)	N/A
N/A	Painted X Walk2?	Yes	N/A	DWS 2 Provided?	N/A
N/A	X Walk 2 Direction	To NW	N/A	DWS 2 Contrast?	N/A
N/A	X Walk 2 Width (In)	122.0	N/A	DWS 2 Length (In)	N/A

Remove & Replace Entire Refuge.

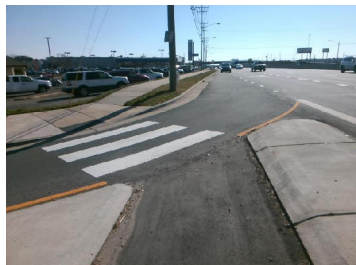
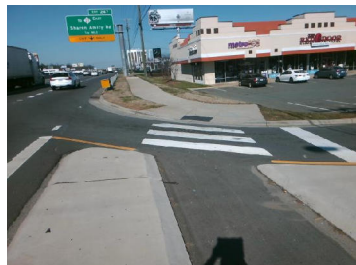
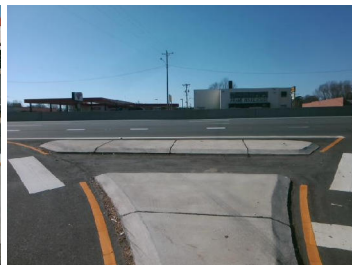
N/A	Road 2 Slope (%)	7.7	N/A	DWS 2 Full Width?	N/A
N/A	Road 2 X Slope (%)	6.3	N/A	DWS 2 Offset (In)	N/A
N/A	Refuge 3 Length (in)	N/A	N/A	Gutter 3 Ponding?	N/A
N/A	Refuge 3 Width (in)	N/A	N/A	Gutter 3 Lip Ht (in)	N/A
N/A	Refuge 3 Slope (%)	N/A	N/A	Gutter 3 Slope (%)	N/A
N/A	Refuge 3 XSlope (%)	N/A	N/A	Gutter 3 XSlope (%)	N/A
N/A	Painted X Walk3?	N/A	N/A	DWS 3 Provided?	N/A
N/A	X Walk 3 Direction	N/A	N/A	DWS 3 Contrast?	N/A
N/A	X Walk 3 Width (in)	N/A	N/A	DWS 3 Length (in)	N/A
N/A	Road 3 Slope (%)	N/A	N/A	DWS 3 Full Width?	N/A
N/A	Road 3 XSlope (%)	N/A	N/A	DWS 3 Offset (in)	N/A
Yes	Any Obstructions?	N/A	N/A	Storm Grate/Utility Hazard?	N/A
N/A	Obstruction Type		N/A	Storm Grate/Utility Type	
		N/A			N/A
N/A	Surface Condition	Good
