## Access Compliance Report Public Rights-of-Way (Curb Ramps)

Intersection ID: 2874Main Street:HORNBEAM\_CTCross Street:LADY\_BANK\_DRLocation:SEADA ID: 2035A570A7E0Ramp Type:PerpInitial Pass/Fail:FailOverall Compliance:NoSeverity Score:10

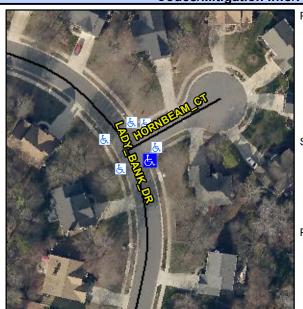
R304.5.1, R304.5.3

Compliance Description		Data	Compliance Description		Data
N/A	Ramp Length (in)	48.0	Yes	Ramp Slope (%)	6.7
No	Ramp Width (in)	38.0	No	Ramp XSlope (%)	2.9
N/A	Flare Type LT	N/A	N/A	Flare Type RT	N/A
N/A	Flare Slope LT (%)	N/A	N/A	Flare Slope RT (%)	N/A
N/A	Flare Traversable LT?	N/A	N/A	Flare Traversable RT?	N/A
N/A	Landing Length (in)	N/A	N/A	DWS Provided?	N/A
N/A	Landing Width (in)	N/A	N/A	DWS Contrast?	N/A
N/A	Landing Slope (%)	N/A	N/A	DWS Length (in)	N/A
N/A	Landing X Slope (%)	N/A	N/A	DWS Full Width?	N/A
N/A	Landing Curb? (Y/N)	N/A	N/A	DWS Offset (in)	N/A
N/A	Shared Landing?	N/A			
N/A	Gutter Ponding?	N/A	N/A	Gutter Slope (%)	N/A
N/A	Gutter Lip Ht (in)	N/A	N/A	Gutter X Slope (%)	N/A
N/A	Painted X Walk1?	No	N/A	Painted X Walk2?	N/A
	X Walk 1 Direction	To W		X Walk 2 Direction	N/A
N/A	X Walk 1 Width (in)	N/A	N/A	X Walk 2 Width (in)	N/A
	X Walk 1 Slope (%)	6.6		X Walk 2 Slope (%)	N/A
	X Walk 1 X Slope (%)	0.2		X Walk 2 X Slope (%)	N/A

Remove & Replace Entire Ramp.
