Access Compliance Report

Public Rights-of-Way

(Island Curb Cuts)

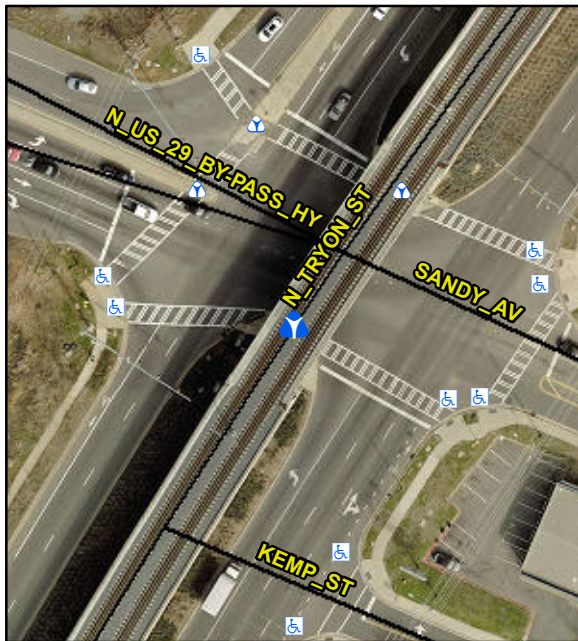
Intersection ID: 6957	Main Street: N_TRYON_ST	Cross Street: N_US_29_BY-PASS_HY	Location: S
ADA ID: F2008C9D04B7	Curb Cut Type: MedianRefuge2	Initial Pass/Fail: Fail	Overall Compliance: No
Severity Score: 1.25			
Codes/Mitigation Info/Possible Solution		Field Measurements/Component Compliance

Remove & Replace Entire Refuge.
