# Access Compliance Report

## Public Rights-of-Way

### (Curb Ramps)

Intersection ID: 10011236	Main Street: N_CHURCH_ST	Cross Street: WADSWORTH_PL	Location: E
ADA ID: 0025755D35A6	Ramp Type: Directional1	Initial Pass/Fail: Pass	Overall Compliance: No
Severity Score: 0			
Codes/Mitigation Info/Possible Solution		Field Measurements/Component Compliance

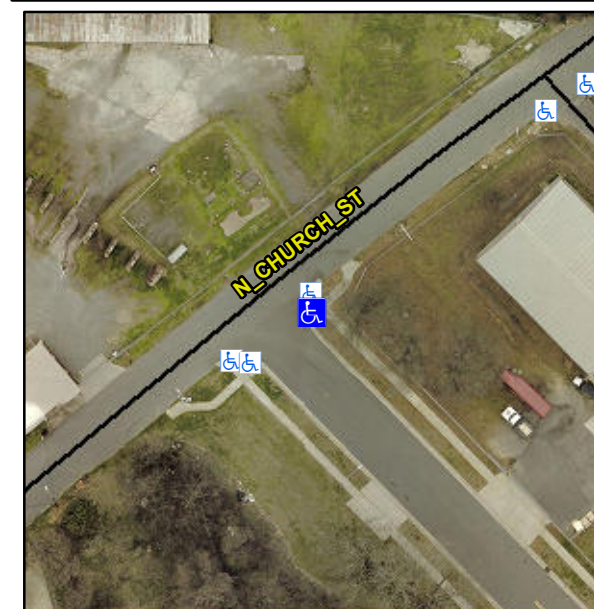
**Not Found, R305.2, R304.5.3**

Compliance	Description	Data	Compliance	Description	Data
N/A	Ramp Length (in)	46.0	Yes	Grade Break?	Yes
Yes	Ramp Width (in)	57.0	Yes	Grade Break Slope (%)	3.6
Yes	Ramp Slope (%)	6.2	Yes	Grade Break XSlope (%)	1.4
Yes	Ramp XSlope (%)	0.0			
Yes	Flare Type LT	N/A	Yes	Flare Type RT	N/A
N/A	Flare Slope LT (%)	N/A	N/A	Flare Slope RT (%)	N/A
N/A	Flare Traversable LT?	No	N/A	Flare Traversable RT?	No
Yes	Landing Length (in)	58.5	Yes	DWS Provided?	Yes
Yes	Landing Width (in)	57.0	Yes	DWS Contrast?	Yes
Yes	Landing Slope (%)	0.8	Yes	DWS Length (in)	24.0
Yes	Landing X Slope (%)	1.6	Yes	DWS Full Width?	Yes
N/A	Landing Curb? (Y/N)	N/A	No	DWS Offset LT (in)	6.0
N/A	Shared Landing?	Yes	Yes	DWS Offset RT (in)	32.0
Yes	Gutter Ponding?	No	Yes	Gutter Slope (%)	4.7
Yes	Gutter Lip Ht (in)	0.0	No	Gutter X Slope (%)	3.3
N/A	Painted X Walk1?	No		Road Slope (%)	1.2
	X Walk 1 Direction	To SW		Road X Slope (%)	3.2
	X Walk 1 Width (in)	N/A		Clear Space?	Yes

X Walk 1 Slope (%)	1.2	N/A	Clear Space to XWalk (in)	N/A
	X Walk 1 X Slope (%)	3.2	Yes	Storm Grate/Utility Hazard?	No
N/A	Ramp inside XWalk1?	N/A		Storm Grate/Utility Type	
Yes	Any Obstructions?	No			N/A
	Obstruction Type		Yes	Surface Condition? (G/P)	Good
			N/A	Curb Slope (%)	16.5

**Remove & Replace Entire Ramp.  
Remove & Replace Gutter.**
