Access Compliance Report

Public Rights-of-Way

(Curb Ramps)

Intersection ID: 45794	Main Street: SHELLVIEW_LN	Cross Street: GRANITE_TRAIL_LN	Location: NW
ADA ID: 0032740474D5	Ramp Type: PerpDiag	Initial Pass/Fail: Fail	Overall Compliance: No
Severity Score: 25			
Codes/Mitigation Info/Possible Solution		Field Measurements/Component Compliance

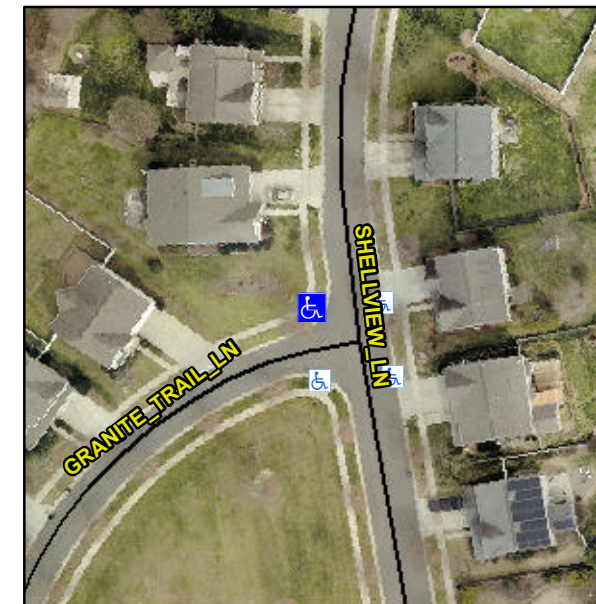
Compliance	Description	Data	Compliance	Description	Data
N/A	Ramp Length (in)	73.5	Yes	Ramp Slope (%)	6.0
Yes	Ramp Width (in)	48.0	No	Ramp XSlope (%)	7.3
N/A	Flare Type LT	N/A	N/A	Flare Type RT	N/A
N/A	Flare Slope LT (%)	N/A	N/A	Flare Slope RT (%)	N/A
N/A	Flare Traversable LT?	N/A	N/A	Flare Traversable RT?	N/A
N/A	Landing Length (in)	N/A	N/A	DWS Provided?	N/A
N/A	Landing Width (in)	N/A	N/A	DWS Contrast?	N/A
N/A	Landing Slope (%)	N/A	N/A	DWS Length (in)	N/A
N/A	Landing X Slope (%)	N/A	N/A	DWS Full Width?	N/A
N/A	Landing Curb? (Y/N)	N/A	N/A	DWS Offset (in)	N/A
N/A	Shared Landing?	N/A			
N/A	Gutter Ponding?	N/A	N/A	Gutter Slope (%)	N/A
N/A	Gutter Lip Ht (in)	N/A	N/A	Gutter X Slope (%)	N/A
N/A	Painted X Walk1?	No	N/A	Painted X Walk2?	No
	X Walk 1 Direction	To S		X Walk 2 Direction	To E
N/A	X Walk 1 Width (in)	N/A	N/A	X Walk 2 Width (in)	N/A
	X Walk 1 Slope (%)	4.5		X Walk 2 Slope (%)	4.1
	X Walk 1 X Slope (%)	1.9		X Walk 2 X Slope (%)	4.1

N/A	Ramp inside XWalk1?	N/A	N/A	Ramp inside XWalk2?	N/A
	Road Slope (%)	3.0	N/A	Clear Space?	N/A
	Road X Slope (%)	1.0	N/A	Clear Space to XWalk (in)	N/A
N/A	Any Obstructions?	N/A	N/A	Storm Grate/Utility Hazard?	N/A
	Obstruction Type			Storm Grate/Utility Type	
		N/A			N/A
			Yes	Surface Condition? (G/P)	Good

Possible Solutions:

Remove & Replace Curb Ramp With Two New Directional Ramps or Equivalent.

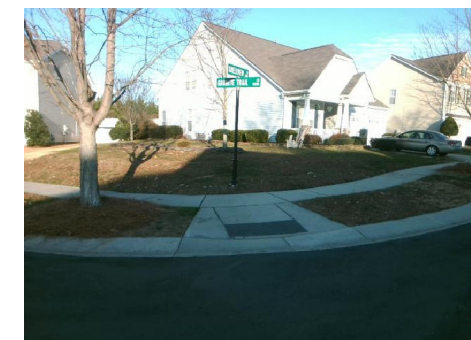
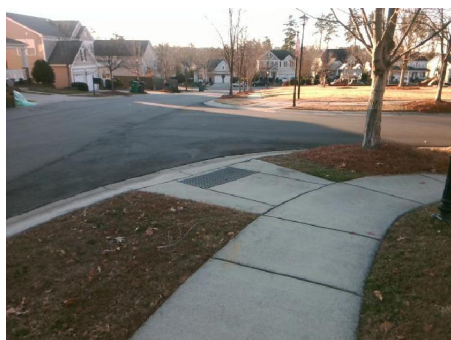
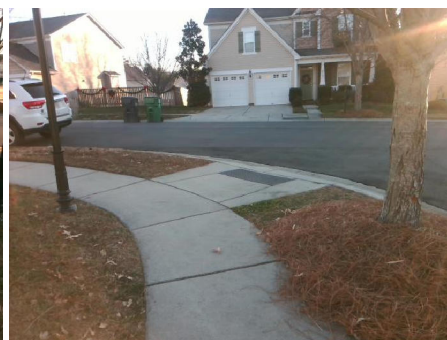
Street 1 Name GEANITE TRAIL LN
 Stop Condition-Street 2 StopSign
 Street 2 Name SHELLVIEW LN
 Stop Condition-Street 1 None
