Intersection ID: 8141	Main Street: CROSSRIDGE_RD	Cross Street: RUNNING_DEER_RD	Location:	E
ADA ID: 0033DD39E09D	Ramp Type: Perp	Initial Pass/Fail: Fail	Overall Compliance: No	Severity Score: 8.75

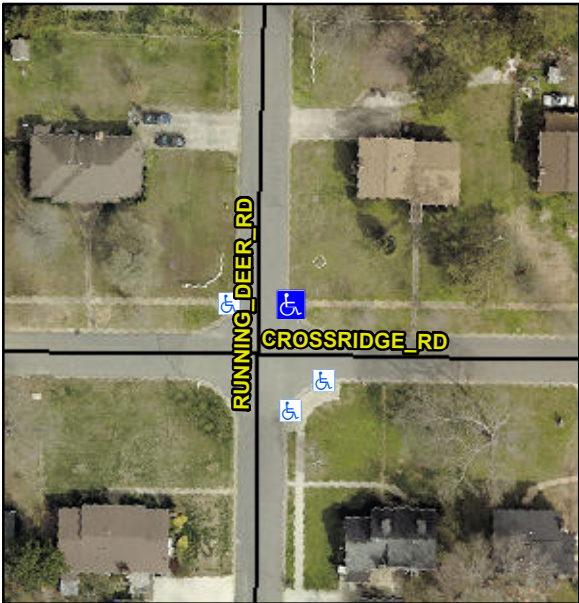
Possible Solutions:		Remove & Replace Entire Ramp.			Compliance	Description	Data	Compliance	Description	Data
						N/A	Ramp Length (in)	98.0	Yes	Ramp Slope (%)	6.1
						No	Ramp Width (in)	46.0	Yes	Ramp XSlope (%)	1.7
						N/A	Flare Type LT	N/A	N/A	Flare Type RT	N/A
						N/A	Flare Slope LT (%)	N/A	N/A	Flare Slope RT (%)	N/A
						N/A	Flare Traversable LT?	N/A	N/A	Flare Traversable RT?	N/A
						N/A	Landing Length (in)	N/A	N/A	DWS Provided?	N/A
						N/A	Landing Width (in)	N/A	N/A	DWS Contrast?	N/A
						N/A	Landing Slope (%)	N/A	N/A	DWS Length (in)	N/A
						N/A	Landing X Slope (%)	N/A	N/A	DWS Full Width?	N/A
Surveyor Notes:		N/A			N/A	Landing Curb? (Y/N)	N/A	N/A	DWS Offset (in)	N/A	
PROW/ADA:		Not Found, R304.5.1			N/A	Shared Landing?	N/A	N/A	Gutter Slope (%)	N/A	
					N/A	Gutter Ponding?	N/A	N/A	Gutter X Slope (%)	N/A

N/A	Gutter Lip Ht (in)	N/A	N/A	Painted X Walk2?	N/A	
					N/A	Painted X Walk1?	No	N/A	X Walk 2 Direction	N/A	
						X Walk 1 Direction	To W		X Walk 2 Width (in)	N/A	
					N/A	X Walk 1 Width (in)	N/A	N/A	X Walk 2 Slope (%)	N/A	
						X Walk 1 Slope (%)	3.8		X Walk 2 X Slope (%)	N/A	
						X Walk 1 X Slope (%)	0.1				
Street 1 Name		RUNNING DEER RD			N/A	Ramp inside XWalk1?	N/A	N/A	Ramp inside XWalk2?	N/A	
Stop Condition-Street 2		StopSign				Road Slope (%)	N/A	N/A	Clear Space?	N/A	
Street 2 Name		N/A				Road X Slope (%)	N/A	N/A	Clear Space to XWalk (in)	N/A	
Stop Condition-Street 1		N/A			N/A	Any Obstructions?	N/A	N/A	Storm Grate/Utility Hazard?	N/A	
						Obstruction Type			Storm Grate/Utility Type		
							N/A			N/A	
								Yes	Surface Condition? (G/P)	Good	
Total Cost:		\$ 1850.00
