Intersection ID: 2457	Main Street: CAMBELLTON_DR	Cross Street: CLARKE_CREEK_PY	Location:	SW
ADA ID: 003BFAD19A25	Ramp Type: PerpDiag	Initial Pass/Fail: Fail	Overall Compliance: No	Severity Score: 10

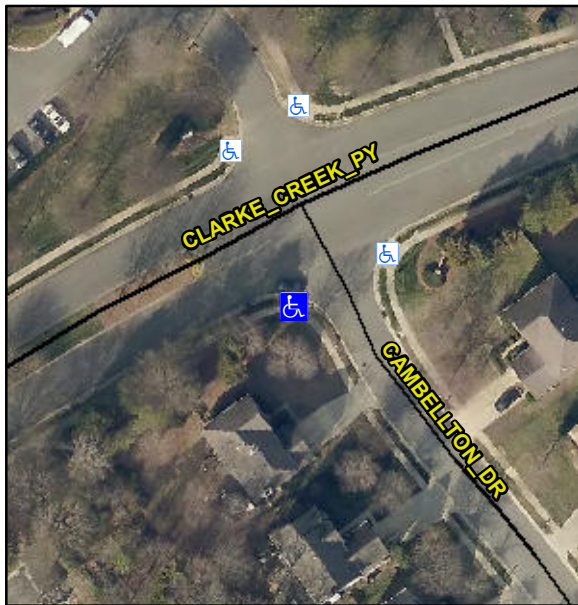
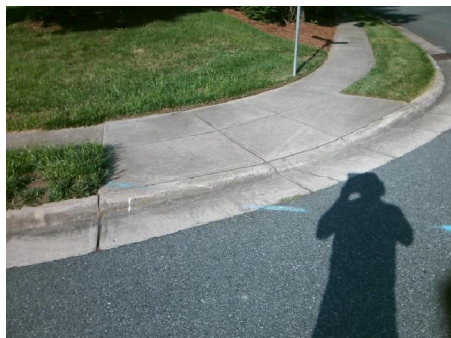
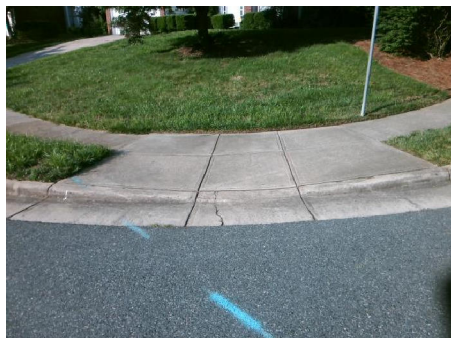
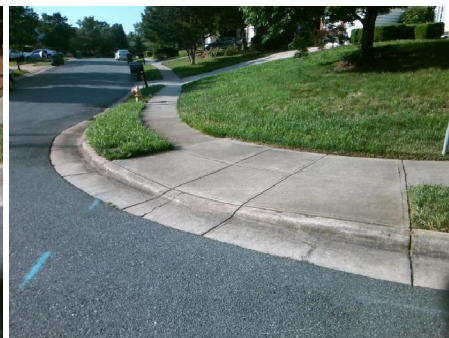
R304.5.1, R304.5.3

Compliance	Description	Data	Compliance	Description	Data
N/A	Ramp Length (in)	49.0	Yes	Ramp Slope (%)	6.7
No	Ramp Width (in)	43.0	No	Ramp XSlope (%)	5.0
N/A	Flare Type LT	N/A	N/A	Flare Type RT	N/A
N/A	Flare Slope LT (%)	N/A	N/A	Flare Slope RT (%)	N/A
N/A	Flare Traversable LT?	N/A	N/A	Flare Traversable RT?	N/A
N/A	Landing Length (in)	N/A	N/A	DWS Provided?	N/A
N/A	Landing Width (in)	N/A	N/A	DWS Contrast?	N/A
N/A	Landing Slope (%)	N/A	N/A	DWS Length (in)	N/A
N/A	Landing X Slope (%)	N/A	N/A	DWS Full Width?	N/A
N/A	Landing Curb? (Y/N)	N/A	N/A	DWS Offset (in)	N/A
N/A	Shared Landing?	N/A			
N/A	Gutter Ponding?	N/A	N/A	Gutter Slope (%)	N/A
N/A	Gutter Lip Ht (in)	N/A	N/A	Gutter X Slope (%)	N/A
N/A	Painted X Walk1?	No	N/A	Painted X Walk2?	No
	X Walk 1 Direction	To E		X Walk 2 Direction	To N
N/A	X Walk 1 Width (in)	N/A	N/A	X Walk 2 Width (in)	N/A
	X Walk 1 Slope (%)	3.2		X Walk 2 Slope (%)	1.9
	X Walk 1 X Slope (%)	1.9		X Walk 2 X Slope (%)	3.6

N/A	Ramp inside XWalk1?	N/A	N/A	Ramp inside XWalk2?	N/A
	Road Slope (%)	4.2	N/A	Clear Space?	N/A
	Road X Slope (%)	0.6	N/A	Clear Space to XWalk (in)	N/A
N/A	Any Obstructions?	N/A	N/A	Storm Grate/Utility Hazard?	N/A
	Obstruction Type			Storm Grate/Utility Type	
		N/A			N/A
			Yes	Surface Condition? (G/P)	Good

Remove & Replace Curb Ramp With Two New Directional Ramps or Equivalent.
