Access Compliance Report Public Rights-of-Way (Curb Ramps)

Intersection ID: 15138	Main Street: FENTON_PL			street:	HEMPSTEAD_PL	Location:	SW		
ADA ID: 004F219172E1	Ramp Ty	Ramp Type: PerpDiag			ail: Fail Overall	o Severity Score:	12.5		
Codes/Mitigation Info/Possible Solution				Field Measurements/Component Compliance					
	E H	Possible Solutions:		Compliance Description			Data Compliance Description		
		Remove & Replace Curb Ramp Wi Two New Directional Ramps or Equivalent.	lith	N/A	Ramp Length (in)	109.0	No	Ramp Slope (%)	8.5

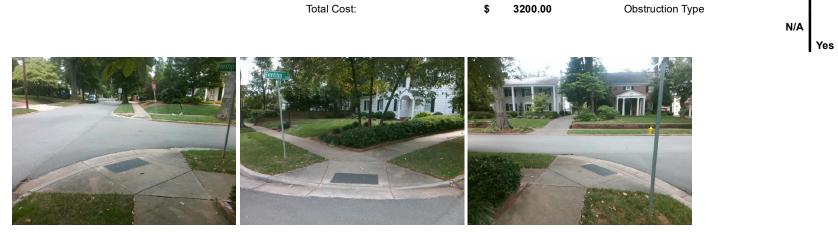
-	Yes	Ramp Width (in)	74.0	Yes	Ramp XSlope (%)	1.4
				N/A	Flare Type LT	N/A	N/A	Flare Type RT	N/A
				N/A	Flare Slope LT (%)	N/A	N/A	Flare Slope RT (%)	N/A
5				N/A	Flare Traversable LT?	N/A	N/A	Flare Traversable RT?	N/A
3				N/A	Landing Length (in)	N/A	N/A	DWS Provided?	N/A
Handar -		Surveyor Notes:		N/A	Landing Width (in)	N/A	N/A	DWS Contrast?	N/A
		N/A		N/A	Landing Slope (%)	N/A	N/A	DWS Length (in)	N/A
and and				N/A	Landing X Slope (%)	N/A	N/A	DWS Full Width?	N/A
A AND AND AND AND AND AND AND AND AND AN				N/A	Landing Curb? (Y/N)	N/A	N/A	DWS Offset (in)	N/A
1 2 20				N/A	Shared Landing?	N/A			
		PROW/ADA:		N/A	Gutter Ponding?	N/A	N/A	Gutter Slope (%)	N/A
the a start	ALL BOARD	R304.2.2		N/A	Gutter Lip Ht (in)	N/A	N/A	Gutter X Slope (%)	N/A
