Access Compliance Report

Public Rights-of-Way

(Curb Ramps)

Intersection ID: 10034401	Main Street: PIEDMONT_PARK_DR	Cross Street: POTOMAC_RIVER_PY	Location: S
ADA ID: 0065285FC8E6	Ramp Type: Directional1	Initial Pass/Fail: Fail	Overall Compliance: No
Severity Score: 25			
Codes/Mitigation Info/Possible Solution		Field Measurements/Component Compliance

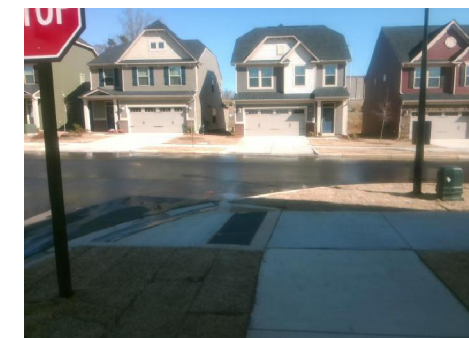
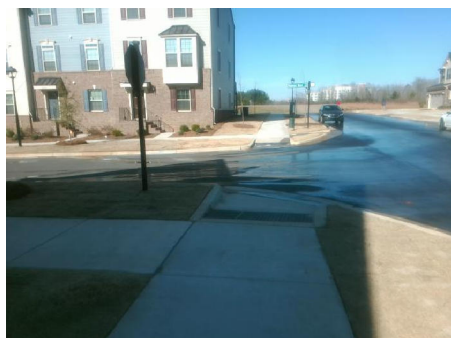
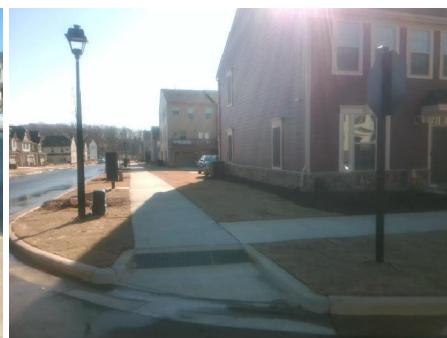
Compliance	Description	Data	Compliance	Description	Data
N/A	Ramp Length (in)	34.0	N/A	Grade Break?	N/A
Yes	Ramp Width (in)	71.0	N/A	Grade Break Slope (%)	0.0
No	Ramp Slope (%)	13.9	N/A	Grade Break XSlope (%)	0.0
Yes	Ramp XSlope (%)	1.1			
N/A	Flare Type LT	N/A	N/A	Flare Type RT	N/A
N/A	Flare Slope LT (%)	N/A	N/A	Flare Slope RT (%)	0.0
N/A	Flare Traversable LT?	N/A	N/A	Flare Traversable RT?	N/A
N/A	Landing Length (in)	0.0	N/A	DWS Provided?	N/A
N/A	Landing Width (in)	0.0	N/A	DWS Contrast?	N/A
N/A	Landing Slope (%)	0.0	N/A	DWS Length (in)	N/A
N/A	Landing X Slope (%)	0.0	N/A	DWS Full Width?	N/A
N/A	Landing Curb? (Y/N)	N/A	N/A	DWS Offset LT (in)	N/A
N/A	Shared Landing?	N/A	N/A	DWS Offset RT (in)	N/A
N/A	Gutter Ponding?	0.0	N/A	Gutter Slope (%)	N/A
N/A	Gutter Lip Ht (in)	0.0	N/A	Gutter X Slope (%)	N/A
N/A	Painted X Walk1?	No		Road Slope (%)	0.7
	X Walk 1 Direction	To NW		Road X Slope (%)	2.5
	X Walk 1 Width (in)	N/A		Clear Space?	N/A

X Walk 1 Slope (%)	0.7	N/A	Clear Space to XWalk (in)	N/A
	X Walk 1 X Slope (%)	2.5	N/A	Storm Grate/Utility Hazard?	N/A
N/A	Ramp inside XWalk1?	N/A		Storm Grate/Utility Type	
N/A	Any Obstructions?	N/A			N/A
	Obstruction Type		Yes	Surface Condition? (G/P)	Good
			N/A	Curb Slope (%)	4.0

Possible Solutions:

Remove & Replace Entire Ramp.
