Access Compliance Report

Public Rights-of-Way

(Curb Ramps)

Intersection ID: 14373	Main Street: EAST_BV	Cross Street: LYNDHURST_AV	Location: SW
ADA ID: 006664323A33	Ramp Type: Directional1	Initial Pass/Fail: Fail	Overall Compliance: No
Codes/Mitigation Info/Possible Solution		Field Measurements/Component Compliance	
Severity Score: 12.5

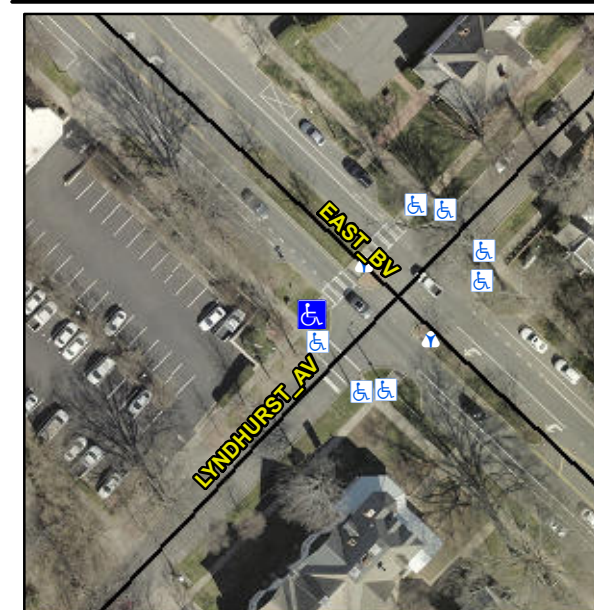
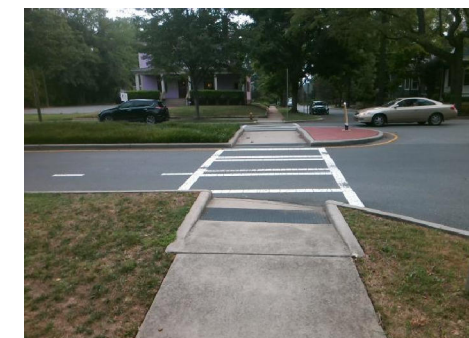
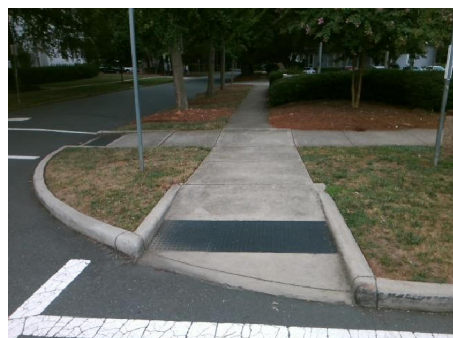
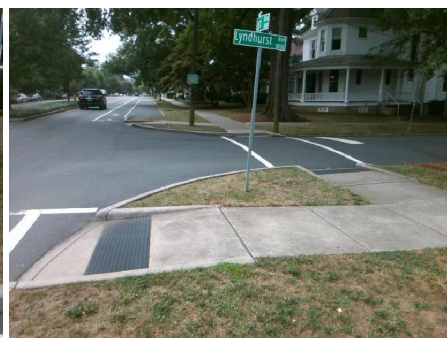
Compliance	Description	Data	Compliance	Description	Data
N/A	Ramp Length (in)	66.0	N/A	Grade Break?	N/A
Yes	Ramp Width (in)	72.0	N/A	Grade Break Slope (%)	0.0
Yes	Ramp Slope (%)	3.6	N/A	Grade Break XSlope (%)	0.0
No	Ramp XSlope (%)	5.8			
N/A	Flare Type LT	N/A	N/A	Flare Type RT	N/A
N/A	Flare Slope LT (%)	N/A	N/A	Flare Slope RT (%)	0.0
N/A	Flare Traversable LT?	N/A	N/A	Flare Traversable RT?	N/A
N/A	Landing Length (in)	0.0	N/A	DWS Provided?	N/A
N/A	Landing Width (in)	0.0	N/A	DWS Contrast?	N/A
N/A	Landing Slope (%)	0.0	N/A	DWS Length (in)	N/A
N/A	Landing X Slope (%)	0.0	N/A	DWS Full Width?	N/A
N/A	Landing Curb? (Y/N)	N/A	N/A	DWS Offset LT (in)	N/A
N/A	Shared Landing?	N/A	N/A	DWS Offset RT (in)	N/A
N/A	Gutter Ponding?	0.0	N/A	Gutter Slope (%)	N/A
N/A	Gutter Lip Ht (in)	0.0	N/A	Gutter X Slope (%)	N/A
N/A	Painted X Walk1?	Yes		Road Slope (%)	5.6
	X Walk 1 Direction	To NE		Road X Slope (%)	0.8
	X Walk 1 Width (in)	112.0		Clear Space?	N/A

X Walk 1 Slope (%)	5.6	N/A	Clear Space to XWalk (in)	N/A
	X Walk 1 X Slope (%)	0.8	N/A	Storm Grate/Utility Hazard?	N/A
N/A	Ramp inside XWalk1?	Yes		Storm Grate/Utility Type	
N/A	Any Obstructions?	N/A			N/A
	Obstruction Type		Yes	Surface Condition? (G/P)	Good
			N/A	Curb Slope (%)	3.7

Possible Solutions:

Remove & Replace Entire Ramp.

R304.5.3

\$ 1600.00
