Access Compliance Report

Public Rights-of-Way

(Curb Ramps)

| Intersection ID: 10019164 | Main Street: STEWARTS_CROSSING_DR | Cross Street: N/A | Location: W |

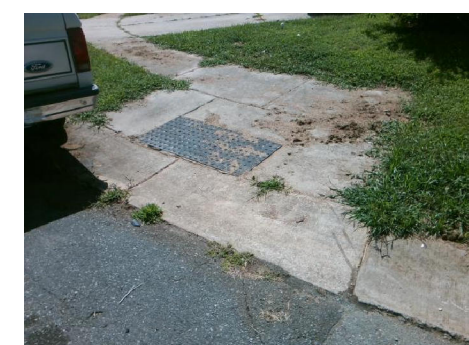
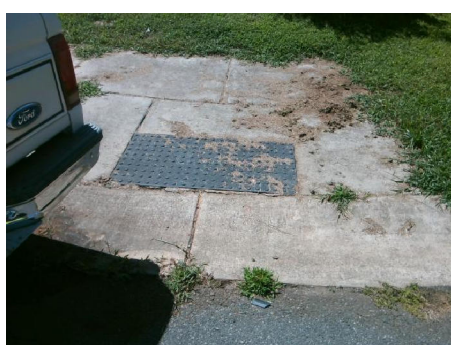
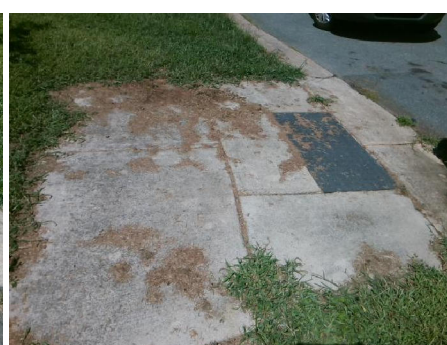
Not Found, R304.5.1, R304.2.2

| Compliance | Description | Data | Compliance | Description | Data |
|---|---|---|---|---|---|
| N/A | Ramp Length (in) | 48.0 | No | Ramp Slope (%) | 8.8 |
| No | Ramp Width (in) | 47.5 | Yes | Ramp XSlope (%) | 1.5 |

Remove & Replace Entire Ramp.
