Access Compliance Report

Public Rights-of-Way

(Curb Ramps)

Intersection ID: 15799	Main Street: MARION_PL	Cross Street: MELBOURNE_CT	Location:	N
ADA ID: 0083B8F69B86	Ramp Type: PerpDiag	Initial Pass/Fail: Fail	Overall Compliance: No	Severity Score: 12.5

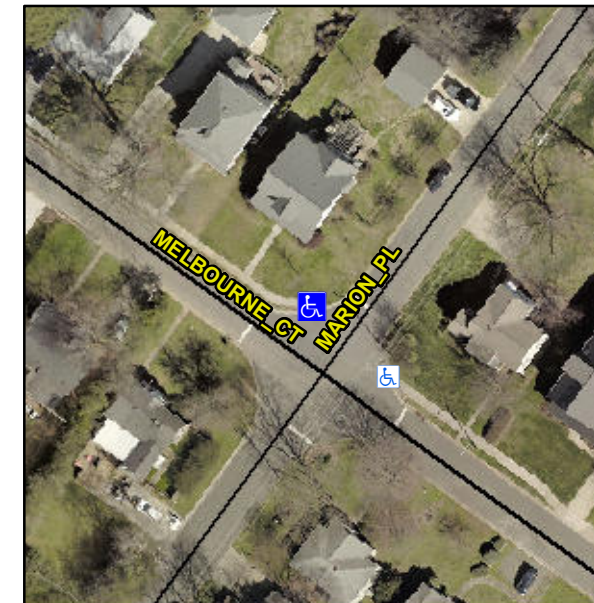
Not Found, R304.2.2

Compliance	Description	Data	Compliance	Description	Data
N/A	Ramp Length (in)	25.0	No	Ramp Slope (%)	9.0
Yes	Ramp Width (in)	48.0	Yes	Ramp XSlope (%)	0.5
N/A	Flare Type LT	N/A	N/A	Flare Type RT	N/A
N/A	Flare Slope LT (%)	N/A	N/A	Flare Slope RT (%)	N/A
N/A	Flare Traversable LT?	N/A	N/A	Flare Traversable RT?	N/A
N/A	Landing Length (in)	N/A	N/A	DWS Provided?	N/A
N/A	Landing Width (in)	N/A	N/A	DWS Contrast?	N/A
N/A	Landing Slope (%)	N/A	N/A	DWS Length (in)	N/A
N/A	Landing X Slope (%)	N/A	N/A	DWS Full Width?	N/A
N/A	Landing Curb? (Y/N)	N/A	N/A	DWS Offset (in)	N/A
N/A	Shared Landing?	N/A			
N/A	Gutter Ponding?	N/A	N/A	Gutter Slope (%)	N/A
N/A	Gutter Lip Ht (in)	N/A	N/A	Gutter X Slope (%)	N/A
N/A	Painted X Walk1?	No	N/A	Painted X Walk2?	No
	X Walk 1 Direction	To SW		X Walk 2 Direction	To SE
N/A	X Walk 1 Width (in)	N/A	N/A	X Walk 2 Width (in)	N/A
	X Walk 1 Slope (%)	0.7		X Walk 2 Slope (%)	2.8
	X Walk 1 X Slope (%)	1.9		X Walk 2 X Slope (%)	0.9

N/A	Ramp inside XWalk1?	N/A	N/A	Ramp inside XWalk2?	N/A
	Road Slope (%)	0.8	N/A	Clear Space?	N/A
	Road X Slope (%)	1.7	N/A	Clear Space to XWalk (in)	N/A
N/A	Any Obstructions?	N/A	N/A	Storm Grate/Utility Hazard?	N/A
	Obstruction Type			Storm Grate/Utility Type	
		N/A			N/A
			Yes	Surface Condition? (G/P)	Good

Remove & Replace Curb Ramp With Two New Directional Ramps or Equivalent.
