# Access Compliance Report

## Public Rights-of-Way

| Intersection ID: N/A | Main Street: KATIE_KIM_DR | Cross Street: CAROWINDS_BV | Location: NE |
| ADA ID: 008E328C8215 | Ramp Type: PerpDiag | Initial Pass/Fail: Fail | Overall Compliance: No |

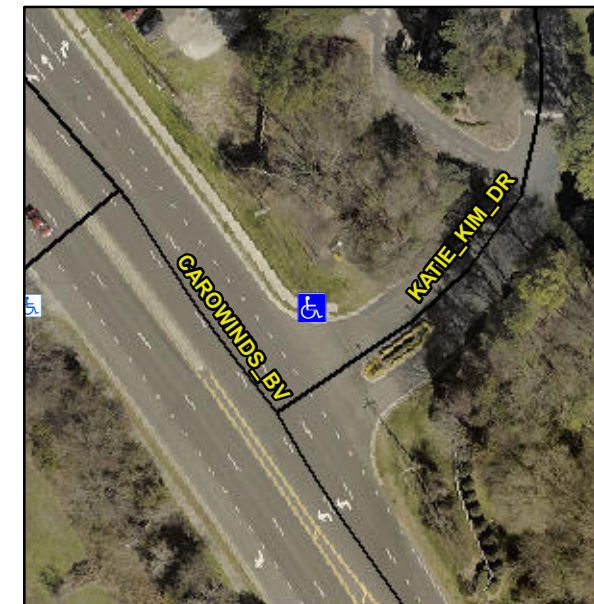
| Severity Score: 25 | | | |

**Not Found, R304.5.3**

| Compliance | Description | Data | Compliance | Description | Data |
|---|---|---|---|---|---|
| Yes | Ramp Width (in) | 48.0 | No | Ramp XSlope (%) | 15.0 |

**Remove & Replace Curb Ramp With Two New Directional Ramps or Equivalent.**

Total Cost: \$ 3200.00
