Access Compliance Report

Public Rights-of-Way

(Curb Ramps)

| Intersection ID: 27355 | Main Street: JOHNSTON_RD | Cross Street: BRIXHAM_AV | Location: NW |

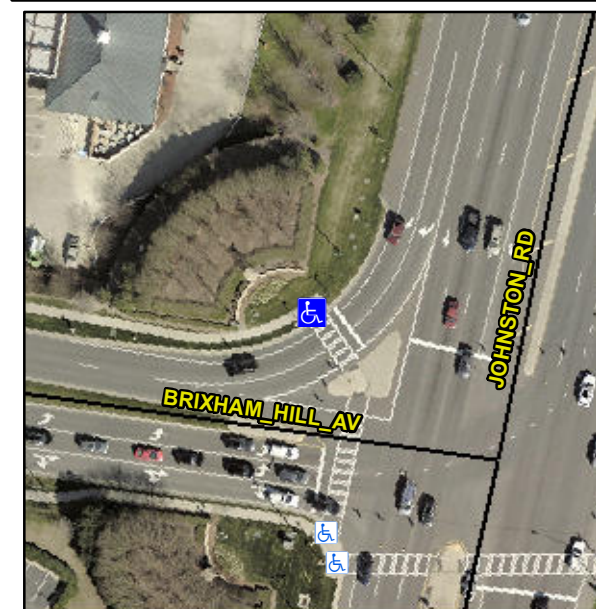
| ADA ID: 0098E61B7CEA | Ramp Type: Perp | Initial Pass/Fail: Fail | Overall Compliance: No |
| Severity Score: 26.25 | | | |

Not Found, R304.2.2, R304.5.3

| Compliance | Description | Data | Compliance | Description | Data |
|---|---|---|---|---|---|
| N/A | Ramp Length (in) | 47.0 | No | Ramp Slope (%) | 13.5 |
| Yes | Ramp Width (in) | 57.0 | No | Ramp XSlope (%) | 4.4 |

Remove & Replace Entire Ramp.

Total Cost: \$ 1850.00
