# Access Compliance Report

## Public Rights-of-Way

### (Curb Ramps)

| Intersection ID: 50764 | Main Street: LAZY_CREEK_LN | Cross Street: QUIET_CREEK_CR | Location: NE |

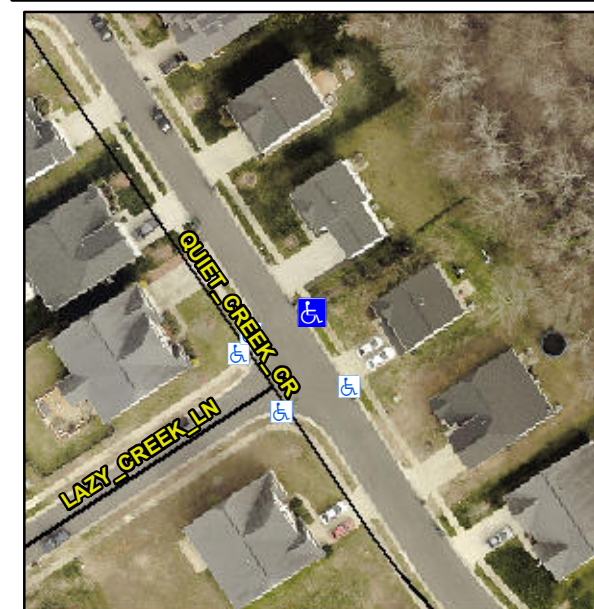
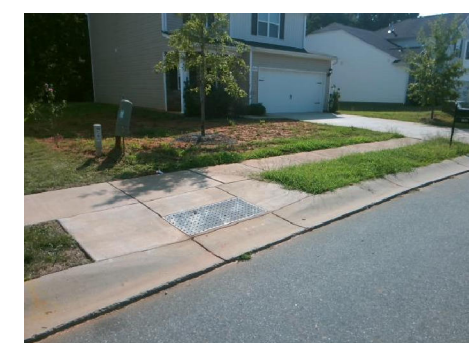
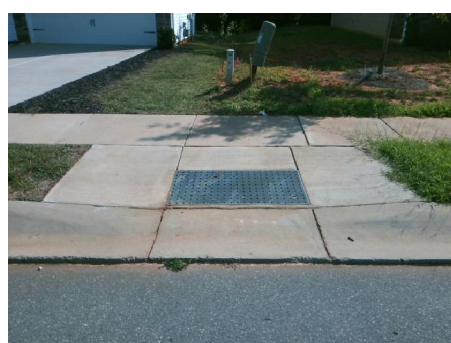
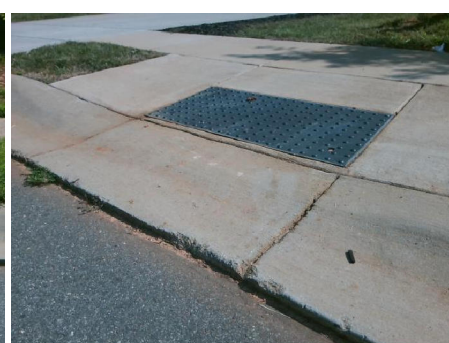
| ADA ID: 009C4E4C5F72 | Ramp Type: Perp | Initial Pass/Fail: Fail | Overall Compliance: No |

**Not Found, R304.5.1, R304.2.2**

| Compliance | Description | Data | Compliance | Description | Data |
|---|---|---|---|---|---|
| N/A | Ramp Length (in) | 48.0 | No | Ramp Slope (%) | 10.8 |
| No | Ramp Width (in) | 47.0 | Yes | Ramp XSlope (%) | 1.8 |

**Remove & Replace Entire Ramp.**
