Access Compliance Report Public Rights-of-Way (Curb Ramps)

Intersection ID: 9076 Main Street: STATESVILLE_AV **Cross Street: MORETZ_AV** Location: NW **Overall Compliance: No ADA ID: 00B86AC036AC** Ramp Type: Perp Initial Pass/Fail: Fail **Severity Score:** 8.75

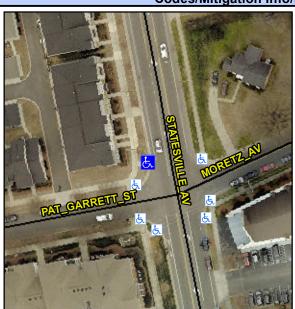
Field Measurements/Component Compliance								
Compl	iance Description	Data	Comp	liance	Description	Data		
N/A	Ramp Length (in)	139.0	Yes	Ramp	Slope (%)	5.2		
No	Ramp Width (in)	46.0	Yes	Ramp	XSlope (%)	1.3		
N/A	Flare Type LT	N/A	N/A	Flare	Type RT	N/A		
N/A	Flare Slope LT (%)	N/A	N/A	Flare	Slope RT (%)	N/A		
N/A	Flare Traversable LT?	N/A	N/A	Flare	Traversable RT?	N/A		
N/A	Landing Length (in)	N/A	N/A	DWS	Provided?	N/A		
N/A	Landing Width (in)	N/A	N/A	DWS	Contrast?	N/A		
N/A	Landing Slope (%)	N/A	N/A	DWS	Length (in)	N/A		
N/A	Landing X Slope (%)	N/A	N/A	DWS	Full Width?	N/A		
N/A	Landing Curb? (Y/N)	N/A	N/A	DWS	Offset (in)	N/A		
N/A	Shared Landing?	N/A						
N/A	Gutter Ponding?	N/A	N/A	Gutte	r Slope (%)	N/A		
N/A	Gutter Lip Ht (in)	N/A	N/A	Gutte	r X Slope (%)	N/A		
N/A	Painted X Walk1?	No	N/A	Paint	ed X Walk2?	N/A		
	X Walk 1 Direction	То Е		X Wa	lk 2 Direction	N/A		
N/A	X Walk 1 Width (in)	N/A	N/A	X Wa	lk 2 Width (in)	N/A

X Walk 1 Slope (%)	2.8		X Wa	lk 2 Slope (%)	N/A		
	X Walk 1 X Slope (%)	0.5		X Wa	lk 2 X Slope (%)	N/A		
N/A	Ramp inside XWalk1?	N/A	N/A	Ram	inside XWalk2?	N/A		
	Road Slope (%)	N/A	N/A	Clear	Space?	N/A		
	Road X Slope (%)	N/A	N/A	Clear	Space to XWalk (in)	N/A		
N/A	Any Obstructions?	N/A	N/A	Storn	n Grate/Utility Hazard?	N/A		
	Obstruction Type			Storn	n Grate/Utility Type			
		N/A				N/A		
			Yes	Surfa	ce Condition? (G/P)	Good

Total Cost:

1850.00
