Access Compliance Report

Public Rights-of-Way

(Curb Ramps)

Intersection ID: N/A	Main Street: MAYFLOWER_RD	Cross Street: NORMA_ST	Location: SW
ADA ID: 0101643A983D	Ramp Type: Directional1	Initial Pass/Fail: Fail	Overall Compliance: No
Codes/Mitigation Info/Possible Solution		Field Measurements/Component Compliance	
Severity Score: 1.25

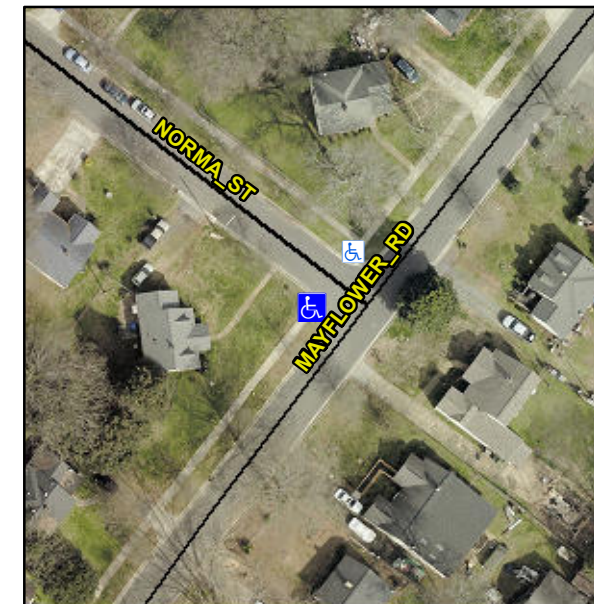
Compliance	Description	Data	Compliance	Description	Data
N/A	Ramp Length (in)	84.0	N/A	Grade Break?	N/A
Yes	Ramp Width (in)	55.0	N/A	Grade Break Slope (%)	0.0
Yes	Ramp Slope (%)	5.1	N/A	Grade Break XSlope (%)	0.0
No	Ramp XSlope (%)	3.2			
N/A	Flare Type LT	N/A	N/A	Flare Type RT	N/A
N/A	Flare Slope LT (%)	N/A	N/A	Flare Slope RT (%)	0.0
N/A	Flare Traversable LT?	N/A	N/A	Flare Traversable RT?	N/A
N/A	Landing Length (in)	0.0	N/A	DWS Provided?	N/A
N/A	Landing Width (in)	0.0	N/A	DWS Contrast?	N/A
N/A	Landing Slope (%)	0.0	N/A	DWS Length (in)	N/A
N/A	Landing X Slope (%)	0.0	N/A	DWS Full Width?	N/A
N/A	Landing Curb? (Y/N)	N/A	N/A	DWS Offset LT (in)	N/A
N/A	Shared Landing?	N/A	N/A	DWS Offset RT (in)	N/A
N/A	Gutter Ponding?	0.0	N/A	Gutter Slope (%)	N/A
N/A	Gutter Lip Ht (in)	0.0	N/A	Gutter X Slope (%)	N/A
N/A	Painted X Walk1?	No		Road Slope (%)	6.3
	X Walk 1 Direction	To NE		Road X Slope (%)	0.3
	X Walk 1 Width (in)	N/A		Clear Space?	N/A

X Walk 1 Slope (%)	6.3	N/A	Clear Space to XWalk (in)	N/A
	X Walk 1 X Slope (%)	0.3	N/A	Storm Grate/Utility Hazard?	N/A
N/A	Ramp inside XWalk1?	N/A		Storm Grate/Utility Type	
N/A	Any Obstructions?	N/A			N/A
	Obstruction Type		Yes	Surface Condition? (G/P)	Good
			N/A	Curb Slope (%)	1.5

Remove & Replace Entire Ramp.

R304.5.3
