Intersection ID: 29190	Main Street: JADE_GLEN_DR	Cross Street: BIG_LEAF_DR	Location:	NW
ADA ID: 010AEE84E2E8	Ramp Type: PerpDiag	Initial Pass/Fail: Fail	Overall Compliance: No	Severity Score: 0

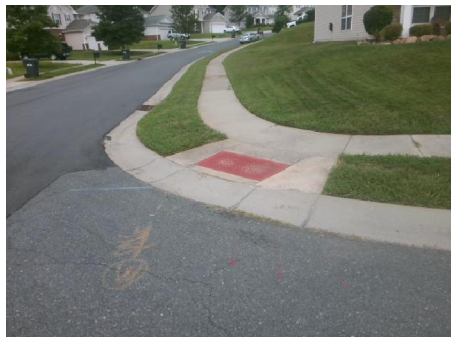
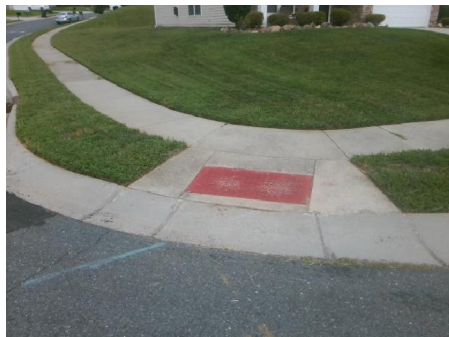
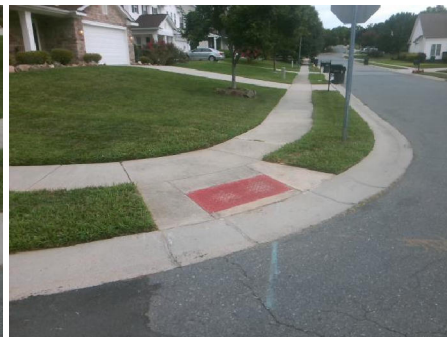
Compliance	Description	Data	Compliance	Description	Data
N/A	Ramp Length (in)	48.0	Yes	Ramp Slope (%)	7.2
Yes	Ramp Width (in)	48.0	Yes	Ramp XSlope (%)	1.2
N/A	Flare Type LT	N/A	N/A	Flare Type RT	N/A
N/A	Flare Slope LT (%)	N/A	N/A	Flare Slope RT (%)	N/A
N/A	Flare Traversable LT?	N/A	N/A	Flare Traversable RT?	N/A
N/A	Landing Length (in)	N/A	N/A	DWS Provided?	N/A
N/A	Landing Width (in)	N/A	N/A	DWS Contrast?	N/A
N/A	Landing Slope (%)	N/A	N/A	DWS Length (in)	N/A
N/A	Landing X Slope (%)	N/A	N/A	DWS Full Width?	N/A
N/A	Landing Curb? (Y/N)	N/A	N/A	DWS Offset (in)	N/A
N/A	Shared Landing?	N/A			
N/A	Gutter Ponding?	N/A	N/A	Gutter Slope (%)	N/A
N/A	Gutter Lip Ht (in)	N/A	N/A	Gutter X Slope (%)	N/A
N/A	Painted X Walk1?	No	N/A	Painted X Walk2?	No
	X Walk 1 Direction	To E		X Walk 2 Direction	To S
N/A	X Walk 1 Width (in)	N/A	N/A	X Walk 2 Width (in)	N/A
	X Walk 1 Slope (%)	4.2		X Walk 2 Slope (%)	3.4
	X Walk 1 X Slope (%)	2.2		X Walk 2 X Slope (%)	1.4

N/A	Ramp inside XWalk1?	N/A	N/A	Ramp inside XWalk2?	N/A
	Road Slope (%)	0.6	N/A	Clear Space?	N/A
	Road X Slope (%)	4.5	N/A	Clear Space to XWalk (in)	N/A
N/A	Any Obstructions?	N/A	N/A	Storm Grate/Utility Hazard?	N/A
	Obstruction Type			Storm Grate/Utility Type	
		N/A			N/A
			Yes	Surface Condition? (G/P)	Good

Remove & Replace Curb Ramp With Two New Directional Ramps or Equivalent.
