# Access Compliance Report

## Public Rights-of-Way

### (Curb Ramps)

Intersection ID: 10154	Main Street: SLOAN_DR	Cross Street: TUCKASEEGEE_RD	Location: N
ADA ID: 0111CD32B0F3	Ramp Type: Perp	Initial Pass/Fail: Fail	Overall Compliance: No
			Severity Score: 21.25

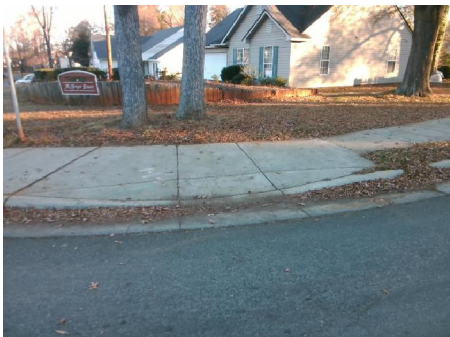
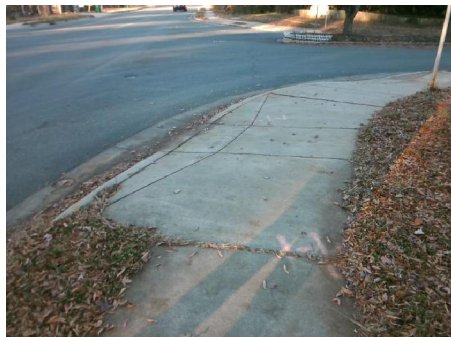
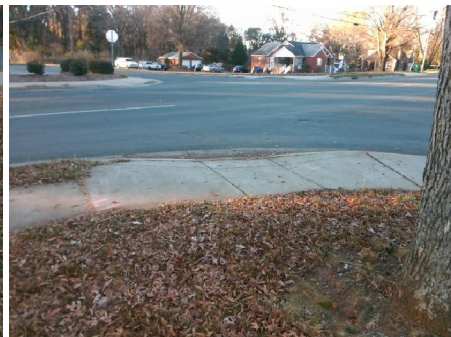
Possible Solutions:		<b>Compliance</b>	<b>Description</b>	<b>Data</b>
	Remove & Replace Entire Ramp.		N/A	Ramp Length (in)	84.0
			No	Ramp Width (in)	40.0
			N/A	Flare Type LT	N/A
			N/A	Flare Slope LT (%)	N/A
			N/A	Flare Traversable LT?	N/A
			N/A	Landing Length (in)	N/A
			N/A	Landing Width (in)	N/A
			N/A	Landing Slope (%)	N/A
			N/A	Landing X Slope (%)	N/A
<p>Surveyor Notes:</p> <p>N/A</p>			N/A	Landing Curb? (Y/N)	N/A
			N/A	Shared Landing?	N/A
			N/A	Gutter Ponding?	Yes
			N/A	Gutter Lip Ht (in)	N/A
			N/A	Painted X Walk1?	No
				X Walk 1 Direction	To S
			N/A	X Walk 1 Width (in)	N/A
				X Walk 1 Slope (%)	3.5
				X Walk 1 X Slope (%)	0.9
			N/A	Ramp inside XWalk1?	N/A
<p>PROW/ADA:</p> <p>Not Found, R304.5.1, R304.2.2</p>			N/A	Road Slope (%)	N/A
				Road X Slope (%)	N/A
			N/A	Any Obstructions?	N/A
				Obstruction Type
