Access Compliance Report

Public Rights-of-Way

(Curb Ramps)

Intersection ID: 15605	Main Street: GREYSTONE_RD	Cross Street: SOUTH_BV	Location: E
ADA ID: 0113607A7ACF	Ramp Type: PerpDiag	Initial Pass/Fail: Fail	Overall Compliance: No
Codes/Mitigation Info/Possible Solution		Field Measurements/Component Compliance	
Severity Score: 8.75

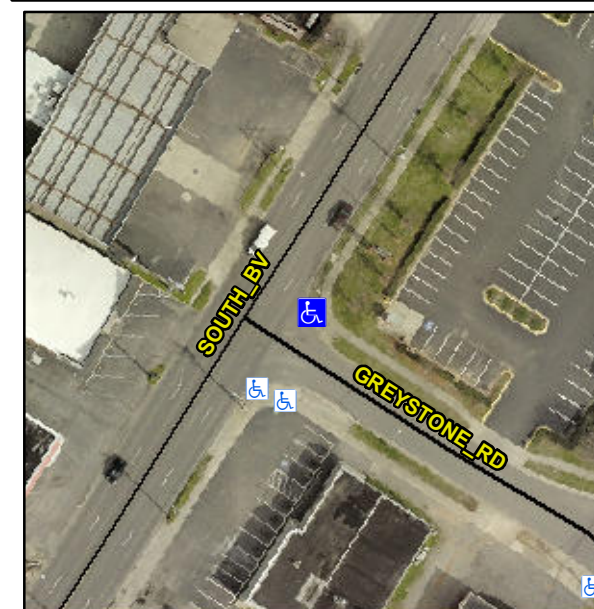
Compliance	Description	Data	Compliance	Description	Data
N/A	Ramp Length (in)	59.0	Yes	Ramp Slope (%)	5.8
No	Ramp Width (in)	42.0	Yes	Ramp XSlope (%)	0.2
N/A	Flare Type LT	N/A	N/A	Flare Type RT	N/A
N/A	Flare Slope LT (%)	N/A	N/A	Flare Slope RT (%)	N/A
N/A	Flare Traversable LT?	N/A	N/A	Flare Traversable RT?	N/A
N/A	Landing Length (in)	N/A	N/A	DWS Provided?	N/A
N/A	Landing Width (in)	N/A	N/A	DWS Contrast?	N/A
N/A	Landing Slope (%)	N/A	N/A	DWS Length (in)	N/A
N/A	Landing X Slope (%)	N/A	N/A	DWS Full Width?	N/A
N/A	Landing Curb? (Y/N)	N/A	N/A	DWS Offset (in)	N/A
N/A	Shared Landing?	N/A			
N/A	Gutter Ponding?	N/A	N/A	Gutter Slope (%)	N/A
N/A	Gutter Lip Ht (in)	N/A	N/A	Gutter X Slope (%)	N/A
N/A	Painted X Walk1?	No	N/A	Painted X Walk2?	No
	X Walk 1 Direction	To NW		X Walk 2 Direction	To SW
N/A	X Walk 1 Width (in)	N/A	N/A	X Walk 2 Width (in)	N/A
	X Walk 1 Slope (%)	2.3		X Walk 2 Slope (%)	1.6
	X Walk 1 X Slope (%)	3.9		X Walk 2 X Slope (%)	0.7

N/A	Ramp inside XWalk1?	N/A	N/A	Ramp inside XWalk2?	N/A
	Road Slope (%)	1.8	N/A	Clear Space?	N/A
	Road X Slope (%)	4.4	N/A	Clear Space to XWalk (in)	N/A
N/A	Any Obstructions?	N/A	N/A	Storm Grate/Utility Hazard?	N/A
	Obstruction Type			Storm Grate/Utility Type	
		N/A			N/A
		Yes		Surface Condition? (G/P)	Good

Possible Solutions:

Remove & Replace Curb Ramp With Two New Directional Ramps or Equivalent.

Not Found, R304.5.1
