Access Compliance Report Public Rights-of-Way (Curb Ramps)

A A ¹					
Intersection ID: 13654	Main Street: S_TRYON_ST		Cross Street: W_PARK_AV			Location:	N	
ADA ID: 0129E709460E	ID: 0129E709460E Ramp Type: Perp		Initial Pass/Fail: Fail Overall Compliance: No			o Severity Score:	13.75	
Codes/Mitigation Info/Possible Solution			Field Measurements/Component Compliance					
		Possible Solutions:	Compliance Description		n Data	Data Compliance Description		Data
	V2 V	Remove & Replace Entire Ramp.	N/A	Ramp Length (in)	36.0	No	Ramp Slope (%)	11.6
A AN A AND AND AND AND AND AND AND AND A	A MARINE		Yes	Ramp Width (in)	48.0	No	Ramp XSlope (%)	3.8
	NN 12		N/A	Flare Type LT	N/A	N/A	Flare Type RT	N/A
THE M	1×1		N/A	Flare Slope LT (%) N/A	N/A	Flare Slope RT (%)	N/A
2			N/A	Flare Traversable	LT? N/A	N/A	Flare Traversable RT?	N/A
and the a			N/A	Landing Length (in	n) N/A	N/A	DWS Provided?	N/A

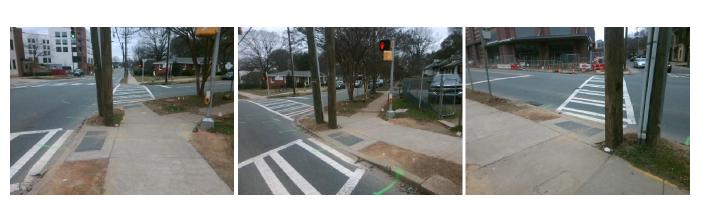
- Level and the	1 3. 1	Surveyor Notes:	N/A	Landing Width (in)	N/A	N/A	DWS Contrast?	N/A
E C	AL & M	N/A	N/A	Landing Slope (%)) N/A	N/A	DWS Length (in)	N/A
			N/A	Landing X Slope (%) N/A	N/A	DWS Full Width?	N/A

S. B. BOLLAR			N/A	Landing Curb? (Y/	'N) N/A	N/A	DWS Offset (in)	N/A
9- <u>6</u> 6	and the second s		N/A	Shared Landing?	N/A			
	The state	PROW/ADA:	N/A	Gutter Ponding?	N/A	N/A	Gutter Slope (%)	N/A
1200.01		R304.2.2, R304.5.3	N/A	Gutter Lip Ht (in)	N/A	N/A	Gutter X Slope (%)	N/A
The second secon	A CONTRACT	,	N/A	Painted X Walk1?	Yes	N/A	Painted X Walk2?	N/A
	1 days			X Walk 1 Direction	To SE		X Walk 2 Direction	N/A
			N/A	X Walk 1 Width (in	97.0	N/A	X Walk 2 Width (in)	N/A
Street 1 Name	S TRYON ST			X Walk 1 Slope (%	b) 5.3		X Walk 2 Slope (%)	N/A
Stop Condition-Street 2	Signal			X Walk 1 X Slope ((%) 0.2		X Walk 2 X Slope (%)	N/A
Street 2 Name	N/A		N/A	Ramp inside XWal	lk1? Yes	N/A	Ramp inside XWalk2?	N/A
Stop Condition-Street 1	N/A			Road Slope (%)	N/A	N/A	Clear Space?	N/A
				Road X Slope (%)	N/A	N/A	Clear Space to XWalk (in)	N/A
			N/A	Any Obstructions?	, N/A	N/A	Storm Grate/Utility Hazard?	N/A
		Total Cost: \$1	850.00	Obstruction Type			Storm Grate/Utility Type

Yes Surface Condition? (G/P)

Good
