Access Compliance Report

Public Rights-of-Way

(Curb Ramps)

Intersection ID: 45789	Main Street: WINDING_RIVER_DR	Cross Street: GARMAN_HILL_DR	Location: SW
ADA ID: 015AF6DBA39B	Ramp Type: BlendTrans1	Initial Pass/Fail: Fail	Overall Compliance: No
			Severity Score: 33.75

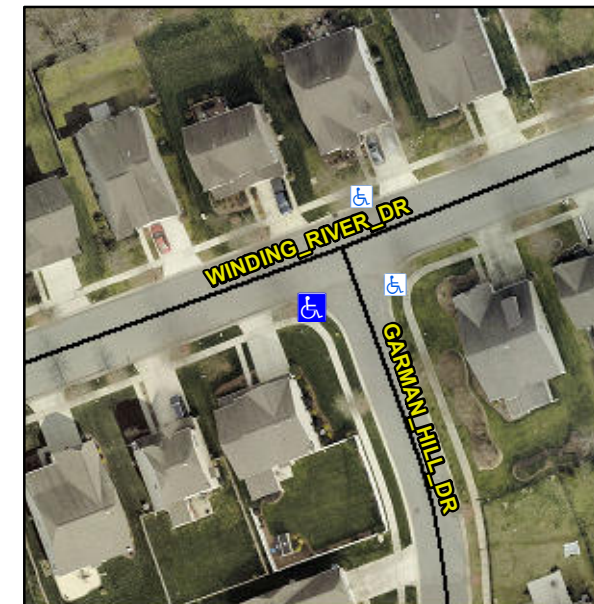
Compliance	Description	Data	Compliance	Description	Data
N/A	Ramp Length (in)	70.0	Yes	BlendTrans Slope (%)	4.0
No	Ramp Width (in)	44.0	No	BlendTrans XSlope (%)	9.5
N/A	Flare Type LT	N/A	N/A	Flare Type RT	N/A
N/A	Flare Slope LT (%)	N/A	N/A	Flare Slope RT (%)	N/A
N/A	Flare Traversable LT?	N/A	N/A	Flare Traversable RT?	N/A
N/A	Landing Length (in)	N/A	N/A	DWS Provided?	N/A
N/A	Landing Width (in)	N/A	N/A	DWS Contrast?	N/A
N/A	Landing Slope (%)	N/A	N/A	DWS Length (in)	N/A
N/A	Landing X Slope (%)	N/A	N/A	DWS Full Width?	N/A
N/A	Landing Curb? (Y/N)	N/A	N/A	DWS Offset (in)	N/A
N/A	Shared Landing?	N/A			
N/A	Gutter Ponding?	N/A	N/A	Gutter Slope (%)	N/A
N/A	Gutter Lip Ht (in)	N/A	N/A	Gutter X Slope (%)	N/A
N/A	Painted X Walk1?	No	N/A	Painted X Walk2?	No
	X Walk 1 Direction	To E		X Walk 2 Direction	To N
	X Walk 1 Width (in)	N/A		X Walk 2 Width (in)	N/A
	X Walk 1 Slope (%)	5.3		X Walk 2 Slope (%)	1.5
	X Walk 1 X Slope (%)	4.1		X Walk 2 X Slope (%)	5.7

N/A	Ramp inside XWalk1?	N/A	N/A	Ramp inside XWalk2?	N/A
	Road Slope (%)	6.2		Clear Space?	N/A
	Road X Slope (%)	3.1	N/A	Clear Space to XWalk (in)	N/A
N/A	Any Obstructions?	N/A	N/A	Storm Grate/Utility Hazard?	N/A
	Obstruction Type			Storm Grate/Utility Type	
		N/A			N/A
			Yes	Surface Condition? (G/P)	Good
			N/A	Curb Slope (%)	1.9

Remove & Replace Curb Ramp With Two New Directional Ramps or Equivalent.

R304.5.1, R304.5.3
