Access Compliance Report Public Rights-of-Way (Curb Ramps)

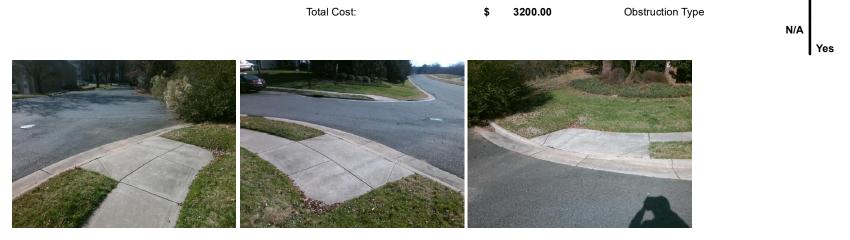
Intersection ID: N/A	ersection ID: N/A Main Street: CROSS POINT CIR		Cross Street: NORTHEAST PWY					Location:	NE
ADA ID: 016E5C139F0F	D: 016E5C139F0F Ramp Type: PerpDiag			Initial Pass/Fail: Fail Overall Compliance: No				o Severity Score:	12.5
Codes/Mitigation Info/Possible Solution				Field Measurements/Component Compliance					
	1 201	Possible Solutions:		Compliance Description		Data Compliance Description		Data	
A CARLES AND A	1 4	Remove & Replace Curb Ramp \	Nith	N/A	Ramp Length (in)	49.0	No	Ramp Slope (%)	8.8
	5 17	Two New Directional Ramps or		Yes	Ramp Width (in)	49.0	Yes	Ramp XSlope (%)	1.8
		Equivalent.		N/A	Flare Type LT	N/A	N/A	Flare Type RT	N/A
	1 1 1 1			N/A	Flare Slope LT (%)	N/A	N/A	Flare Slope RT (%)	N/A

W. C.	the second			N/A	Flare Traversable LT?	No	N/A	Flare Traversable RT?	No
	B			N/A	Landing Length (in)	N/A	N/A	DWS Provided?	N/A
and the second se		Surveyor Notes:		N/A	Landing Width (in)	N/A	N/A	DWS Contrast?	N/A
TOPS FOUND		N/A		N/A	Landing Slope (%)	N/A	N/A	DWS Length (in)	N/A
				N/A	Landing X Slope (%)	N/A	N/A	DWS Full Width?	N/A
the second second	1 4 1 1 4 1 4 1 4 1 4 1 4 1 4 1 4 1 4 1			N/A	Landing Curb? (Y/N)	N/A	N/A	DWS Offset (in)	N/A
2	11 -			N/A	Shared Landing?	N/A			
		PROW/ADA:		N/A	Gutter Ponding?	N/A	N/A	Gutter Slope (%)	N/A
		Not Found, R304.2.2		N/A	Gutter Lip Ht (in)	N/A	N/A	Gutter X Slope (%)	N/A
	N 18 2 1			N/A	Painted X Walk1?	No	N/A	Painted X Walk2?	No
12				X Walk 1 Direction	To S		X Walk 2 Direction	To W	
				N/A	X Walk 1 Width (in)	N/A	N/A	X Walk 2 Width (in)	N/A
Street 1 Name CROS	S POINT CIR	-			X Walk 1 Slope (%)	0.9		X Walk 2 Slope (%)	0.4
Stop Condition-Street 2	None				X Walk 1 X Slope (%)	2.6		X Walk 2 X Slope (%)	5.1

Street 2 Name NORT	HEAST PWY			N/A	Ramp inside XWalk1?	N/A	N/A	Ramp inside XWalk2?	N/A
Stop Condition-Street 1	None				Road Slope (%)	2.7	N/A	Clear Space?	N/A
					Road X Slope (%)	3.7	N/A	Clear Space to XWalk (in)	N/A
				N/A	Any Obstructions?	N/A	N/A	Storm Grate/Utility Hazard?	N/A
		Total Cost: \$	3200.00		Obstruction Type			Storm Grate/Utility Type	
						N/A			N/A
