Access Compliance Report Public Rights-of-Way (Curb Ramps)

Intersection ID: 13159 Main Street: CENTRAL_AV Cross Street: NANDINA_ST Location: SW

ADA ID: 017A02D67D0C Ramp Type: PerpDiag Initial Pass/Fail: Fail Overall Compliance: No Severity Score: 8.75

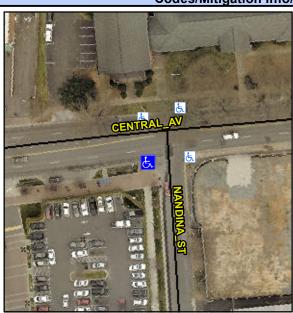
Street 1 Name CENTRAL AV
Stop Condition-Street 2 StopSign
Street 2 Name NANDINA ST
Stop Condition-Street 1 None

Possible Solutions: Compliance Description N/A Ramp Length (in) Remove & Replace Curb Ramp With Two New Directional Ramps or No Ramp Width (in) Equivalent. N/A Flare Type LT N/A Flare Slope LT (%) N/A Flare Traversable LT? N/A Landing Length (in) Surveyor Notes: N/A Landing Width (in) N/A N/A Landing Slope (%) N/A Landing X Slope (%) N/A Landing Curb? (Y/N) N/A Shared Landing? PROW/ADA: N/A **Gutter Ponding?** Not Found, R304.5.1 N/A Gutter Lip Ht (in) N/A Painted X Walk1? X Walk 1 Direction N/A X Walk 1 Width (in) X Walk 1 Slope (%) X Walk 1 X Slope (%) N/A Ramp inside XWalk1? Road Slope (%) Road X Slope (%)
