# Access Compliance Report

## Public Rights-of-Way

### (Curb Ramps)

Intersection ID: 9406	Main Street: CONDON_ST	Cross Street: OAKLAWN_AV	Location: NW
ADA ID: 017B2DC790A8	Ramp Type: Combination1Diag	Initial Pass/Fail: Fail	Overall Compliance: No
		Severity Score: 0

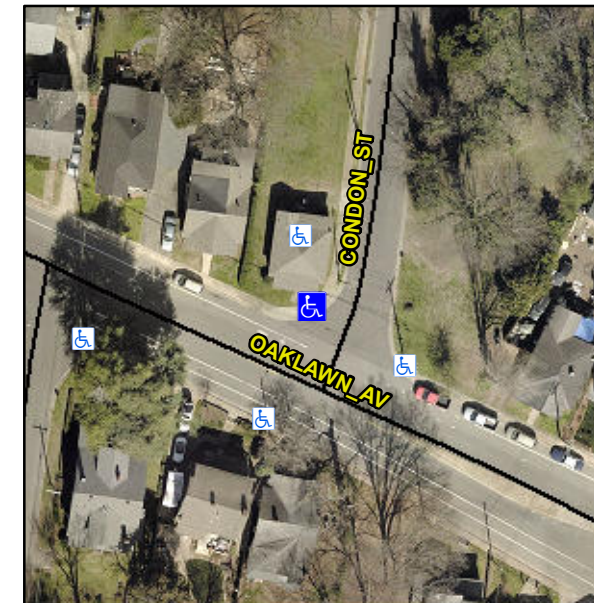
**RT RP < 5%**

**Not Found, R304.5.1, R304.5.1, R304.5.3**

Compliance	Description	Data	Compliance	Description	Data
N/A	Ramp Length LT (in)	58.0	N/A	Ramp Length RT (in)	55.5
No	Ramp Width LT (in)	31.0	No	Ramp Width RT (in)	32.0
Yes	Ramp Slope LT (%)	7.3	Yes	Ramp Slope RT (%)	0.8
No	Ramp XSlope LT (%)	6.0	No	Ramp XSlope RT (%)	2.1
N/A	Ramp Length (in)	25.0	Yes	Ramp Slope (%)	5.1
No	Ramp Width (in)	45.0	No	Ramp XSlope (%)	3.4
N/A	Flare Type LT	N/A	N/A	Flare Type RT	N/A
N/A	Flare Slope LT (%)	N/A	N/A	Flare Slope RT (%)	N/A
N/A	Flare Traversable LT?	N/A	N/A	Flare Traversable RT?	N/A
N/A	Landing Length (in)	N/A	N/A	DWS Provided?	N/A
N/A	Landing Width (in)	N/A	N/A	DWS Contrast?	N/A
N/A	Landing Slope (%)	N/A	N/A	DWS Length (in)	N/A
N/A	Landing X Slope (%)	N/A	N/A	DWS Full Width?	N/A
N/A	Landing Curb? (Y/N)	N/A	N/A	DWS Offset (in)	N/A
N/A	Shared Landing?	N/A			
N/A	Gutter Ponding?	N/A	N/A	Gutter Slope (%)	N/A
N/A	Gutter Lip Ht (in)	N/A	N/A	Gutter X Slope (%)	N/A
N/A	Painted X Walk1?	No	N/A	Painted X Walk2?	No

X Walk 1 Direction	To SW		X Walk 2 Direction	To SE
	X Walk 1 Width (in)	N/A		X Walk 2 Width (in)	N/A
	X Walk 1 Slope (%)	3.2		X Walk 2 Slope (%)	1.9
	X Walk 1 X Slope (%)	1.5		X Walk 2 X Slope (%)	3.1
N/A	Ramp inside XWalk1?	N/A	N/A	Ramp inside XWalk2?	N/A
	Road Slope (%)	4.2		Clear Space?	N/A
	Road X Slope (%)	1.1	N/A	Clear Space to XWalk (in)	N/A
			N/A	Any Obstruction?	N/A
				Obstruction Type	N/A
			N/A	Storm Grate/Utility Hazard?	N/A
				Storm Grate/Utility Type	N/A
					N/A
Yes	Surface Condition? (G/P)	Good			
	Curb Slope (%)	16.2

**Remove & Replace Curb Ramp With Two New Directional Ramps or Equivalent.**
