Access Compliance Report

Public Rights-of-Way

(Curb Ramps)

Intersection ID: 10369	Main Street: DOLPHIN_LN	Cross Street: SHANNONHOUSE_DR	Location: S
ADA ID: 01808B854180	Ramp Type: BlendTrans1	Initial Pass/Fail: Fail	Overall Compliance: No
Severity Score: 1.25			
Codes/Mitigation Info/Possible Solution		Field Measurements/Component Compliance

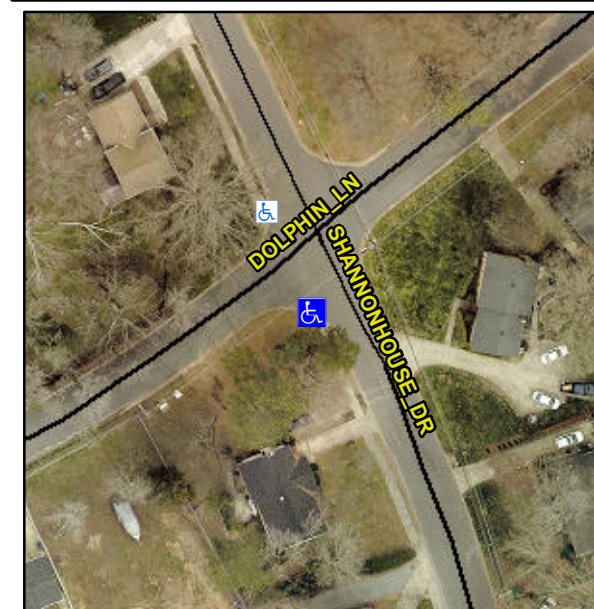
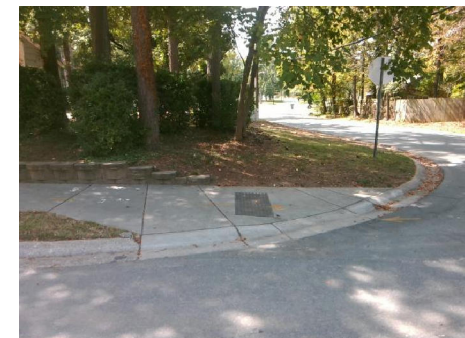
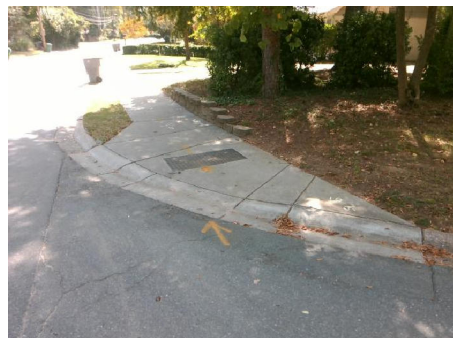
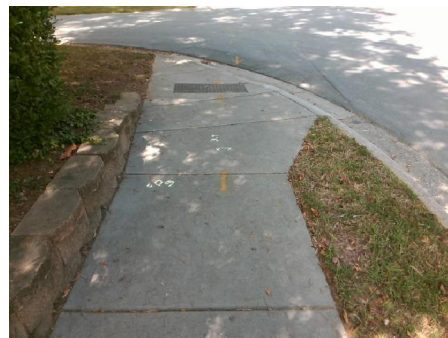
Not Found, R304.5.3

Compliance	Description	Data	Compliance	Description	Data
N/A	Ramp Length (in)	70.0	Yes	BlendTrans Slope (%)	3.9
Yes	Ramp Width (in)	60.0	No	BlendTrans XSlope (%)	2.3
N/A	Flare Type LT	N/A	N/A	Flare Type RT	N/A
N/A	Flare Slope LT (%)	N/A	N/A	Flare Slope RT (%)	N/A
N/A	Flare Traversable LT?	N/A	N/A	Flare Traversable RT?	N/A
N/A	Landing Length (in)	N/A	N/A	DWS Provided?	N/A
N/A	Landing Width (in)	N/A	N/A	DWS Contrast?	N/A
N/A	Landing Slope (%)	N/A	N/A	DWS Length (in)	N/A
N/A	Landing X Slope (%)	N/A	N/A	DWS Full Width?	N/A
N/A	Landing Curb? (Y/N)	N/A	N/A	DWS Offset (in)	N/A
N/A	Shared Landing?	N/A			
N/A	Gutter Ponding?	N/A	N/A	Gutter Slope (%)	N/A
N/A	Gutter Lip Ht (in)	N/A	N/A	Gutter X Slope (%)	N/A
N/A	Painted X Walk1?	No	N/A	Painted X Walk2?	N/A
	X Walk 1 Direction	To NW		X Walk 2 Direction	N/A
	X Walk 1 Width (in)	N/A		X Walk 2 Width (in)	N/A
	X Walk 1 Slope (%)	1.5		X Walk 2 Slope (%)	N/A
	X Walk 1 X Slope (%)	1.0		X Walk 2 X Slope (%)	N/A

N/A	Ramp inside XWalk1?	N/A	N/A	Ramp inside XWalk2?	N/A
	Road Slope (%)	1.0		Clear Space?	N/A
	Road X Slope (%)	1.5	N/A	Clear Space to XWalk (in)	N/A
N/A	Any Obstructions?	N/A	N/A	Storm Grate/Utility Hazard?	N/A
	Obstruction Type			Storm Grate/Utility Type	
		N/A			N/A
			Yes	Surface Condition? (G/P)	Good
			No	Curb Slope (%)	24.8

Possible Solutions:

Remove & Replace Curb Ramp With Two New Directional Ramps or Equivalent.
