Intersection ID: 27418 Main Street: BALLANTYNE_COMMONS_PY Cross Street: BALLANTYNE_TRACE_CT Location: SW

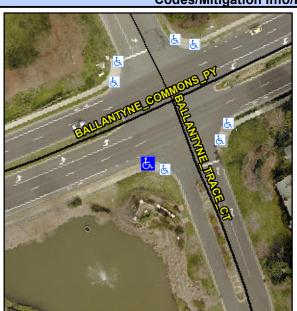
ADA ID: 018A1B829896 Ramp Type: Perp Initial Pass/Fail: Fail Overall Compliance: No Severity Score: 25

Fleid Measurements/Component Compnance									
Compliance Description		Data	Comp	Data					
N/A	Ramp Length (in)	50.0	Yes	Ramp Slope (%)	5.0				
Yes	Ramp Width (in)	48.0	No	Ramp XSlope (%)	7.0				
N/A	Flare Type LT	N/A	N/A	Flare Type RT	N/A				
N/A	Flare Slope LT (%)	N/A	N/A	Flare Slope RT (%)	N/A				
N/A	Flare Traversable LT?	N/A	N/A	Flare Traversable RT?	N/A				
N/A	Landing Length (in)	N/A	N/A	DWS Provided?	N/A				
N/A	Landing Width (in)	N/A	N/A	DWS Contrast?	N/A				
N/A	Landing Slope (%)	N/A	N/A	DWS Length (in)	N/A				
N/A	Landing X Slope (%)	N/A	N/A	DWS Full Width?	N/A				
N/A	Landing Curb? (Y/N)	N/A	N/A	DWS Offset (in)	N/A				
N/A	Shared Landing?	N/A							
N/A	Gutter Ponding?	N/A	N/A	Gutter Slope (%)	N/A				
N/A	Gutter Lip Ht (in)	N/A	N/A	Gutter X Slope (%)	N/A				
N/A	Painted X Walk1?	No	N/A	Painted X Walk2?	N/A				
	X Walk 1 Direction	To N		X Walk 2 Direction	N/A				
N/A	X Walk 1 Width (in)	N/A	N/A	X Walk 2 Width (in)	N/A

X Walk 1 Slope (%)	6.9		X Walk 2 Slope (%)	N/A				
	X Walk 1 X Slope (%)	3.9		X Walk 2 X Slope (%)	N/A				
N/A	Ramp inside XWalk1?	N/A	N/A	Ramp inside XWalk2?	N/A				
	Road Slope (%)	N/A	N/A	Clear Space?	N/A				
	Road X Slope (%)	N/A	N/A	Clear Space to XWalk (in)	N/A				
N/A	Any Obstructions?	N/A	N/A	Storm Grate/Utility Hazard?	N/A				
	Obstruction Type			Storm Grate/Utility Type					
		N/A			N/A				
			Yes	Surface Condition? (G/P)	Good

Possible Solutions:

Remove & Replace Entire Ramp.

Not Found, R304.5.3
