Access Compliance Report

Public Rights-of-Way

(Curb Ramps)

Intersection ID: N/A	Main Street: BYRUM_DR	Cross Street: PINEY_TOP_DR	Location: SW
ADA ID: 018F622C5631	Ramp Type: Perp	Initial Pass/Fail: Fail	Overall Compliance: No
Codes/Mitigation Info/Possible Solution		Field Measurements/Component Compliance

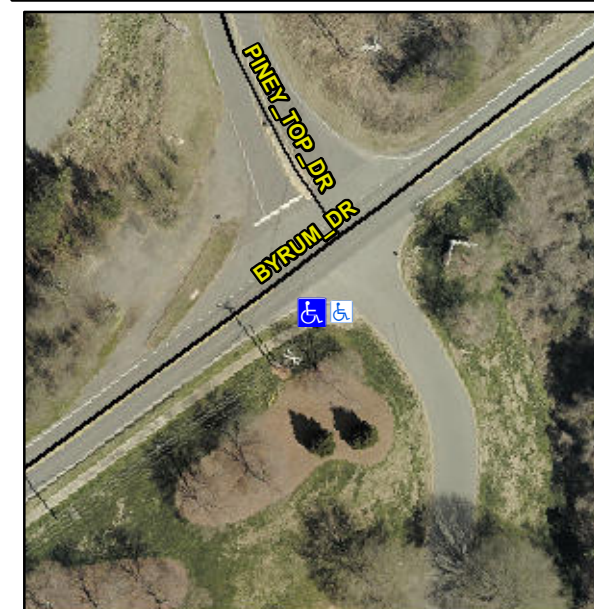
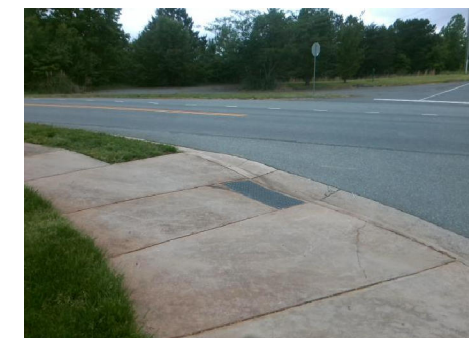
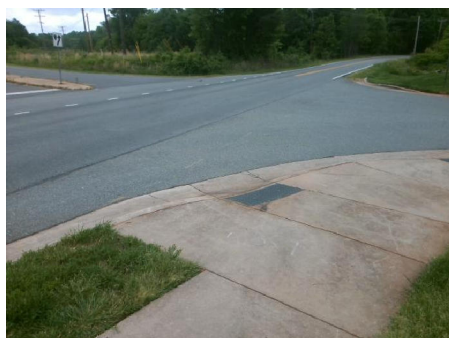
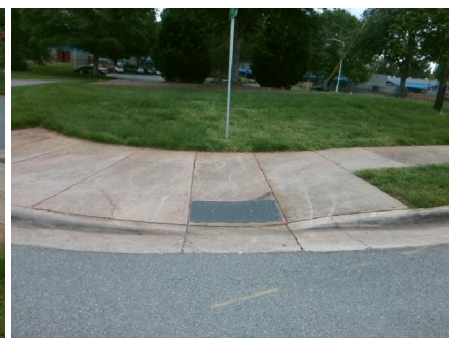
R304.5.1, R304.2.2, R304.5.3

Compliance	Description	Data	Compliance	Description	Data
N/A	Ramp Length (in)	119.0	No	Ramp Slope (%)	9.5
No	Ramp Width (in)	46.0	No	Ramp XSlope (%)	11.3
N/A	Flare Type LT	N/A	N/A	Flare Type RT	N/A
N/A	Flare Slope LT (%)	N/A	N/A	Flare Slope RT (%)	N/A
N/A	Flare Traversable LT?	N/A	N/A	Flare Traversable RT?	N/A
N/A	Landing Length (in)	N/A	N/A	DWS Provided?	N/A
N/A	Landing Width (in)	N/A	N/A	DWS Contrast?	N/A
N/A	Landing Slope (%)	N/A	N/A	DWS Length (in)	N/A
N/A	Landing X Slope (%)	N/A	N/A	DWS Full Width?	N/A
N/A	Landing Curb? (Y/N)	N/A	N/A	DWS Offset (in)	N/A
N/A	Shared Landing?	N/A			
N/A	Gutter Ponding?	N/A	N/A	Gutter Slope (%)	N/A
N/A	Gutter Lip Ht (in)	N/A	N/A	Gutter X Slope (%)	N/A
N/A	Painted X Walk1?	No	N/A	Painted X Walk2?	N/A
	X Walk 1 Direction	To N		X Walk 2 Direction	N/A
N/A	X Walk 1 Width (in)	N/A	N/A	X Walk 2 Width (in)	N/A
	X Walk 1 Slope (%)	8.1		X Walk 2 Slope (%)	N/A
	X Walk 1 X Slope (%)	3.6		X Walk 2 X Slope (%)	N/A

N/A	Ramp inside XWalk1?	N/A	N/A	Ramp inside XWalk2?	N/A
	Road Slope (%)	N/A	N/A	Clear Space?	N/A
	Road X Slope (%)	N/A	N/A	Clear Space to XWalk (in)	N/A
N/A	Any Obstructions?	N/A	N/A	Storm Grate/Utility Hazard?	N/A
	Obstruction Type			Storm Grate/Utility Type	
		N/A			N/A
			Yes	Surface Condition? (G/P)	Good

Remove & Replace Entire Ramp.
