Access Compliance Report

Public Rights-of-Way

(Curb Ramps)

Intersection ID: 26367	Main Street: BEVINGTON_PL	Cross Street: GLYNMOOR_LAKES_DR	Location: NW
ADA ID: 01A5C5269085	Ramp Type: PerpDiag	Initial Pass/Fail: Fail	Overall Compliance: No
		Severity Score: 8.75

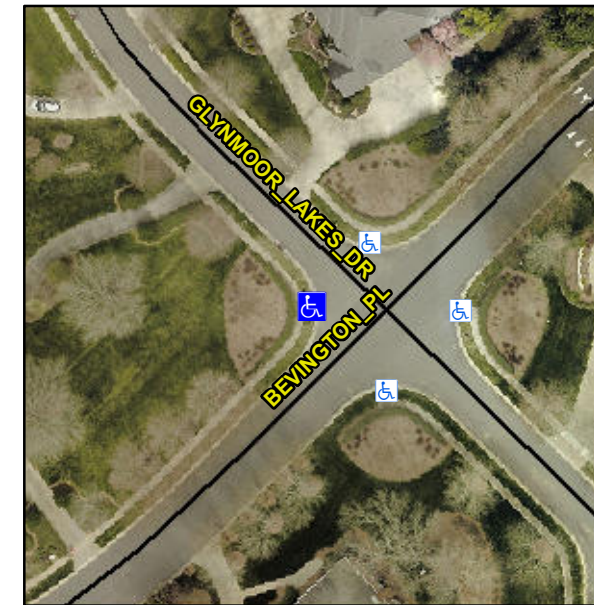
Compliance	Description	Data	Compliance	Description	Data
N/A	Ramp Length (in)	114.0	Yes	Ramp Slope (%)	8.0
No	Ramp Width (in)	37.0	Yes	Ramp XSlope (%)	0.7
N/A	Flare Type LT	N/A	N/A	Flare Type RT	N/A
N/A	Flare Slope LT (%)	N/A	N/A	Flare Slope RT (%)	N/A
N/A	Flare Traversable LT?	N/A	N/A	Flare Traversable RT?	N/A
N/A	Landing Length (in)	N/A	N/A	DWS Provided?	N/A
N/A	Landing Width (in)	N/A	N/A	DWS Contrast?	N/A
N/A	Landing Slope (%)	N/A	N/A	DWS Length (in)	N/A
N/A	Landing X Slope (%)	N/A	N/A	DWS Full Width?	N/A
N/A	Landing Curb? (Y/N)	N/A	N/A	DWS Offset (in)	N/A
N/A	Shared Landing?	N/A			
N/A	Gutter Ponding?	N/A	N/A	Gutter Slope (%)	N/A
N/A	Gutter Lip Ht (in)	N/A	N/A	Gutter X Slope (%)	N/A
N/A	Painted X Walk1?	No	N/A	Painted X Walk2?	No
	X Walk 1 Direction	To SE		X Walk 2 Direction	To NE
N/A	X Walk 1 Width (in)	N/A	N/A	X Walk 2 Width (in)	N/A
	X Walk 1 Slope (%)	1.7		X Walk 2 Slope (%)	1.0
	X Walk 1 X Slope (%)	0.8		X Walk 2 X Slope (%)	1.1

N/A	Ramp inside XWalk1?	N/A	N/A	Ramp inside XWalk2?	N/A
	Road Slope (%)	1.2	N/A	Clear Space?	N/A
	Road X Slope (%)	2.2	N/A	Clear Space to XWalk (in)	N/A
N/A	Any Obstructions?	N/A	N/A	Storm Grate/Utility Hazard?	N/A
	Obstruction Type			Storm Grate/Utility Type	
		N/A			N/A
			Yes	Surface Condition? (G/P)	Good

Possible Solutions:

Remove & Replace Curb Ramp With Two New Directional Ramps or Equivalent.

R304.5.1
