# Access Compliance Report

## Public Rights-of-Way

### (Curb Ramps)

Intersection ID: 18795	Main Street: LAMONT_DR	Cross Street: SENECA_PL	Location: NW
ADA ID: 01AD985B9B3C	Ramp Type: PerpDiag	Initial Pass/Fail: Fail	Overall Compliance: No
Severity Score: 33.75			
Codes/Mitigation Info/Possible Solution		Field Measurements/Component Compliance

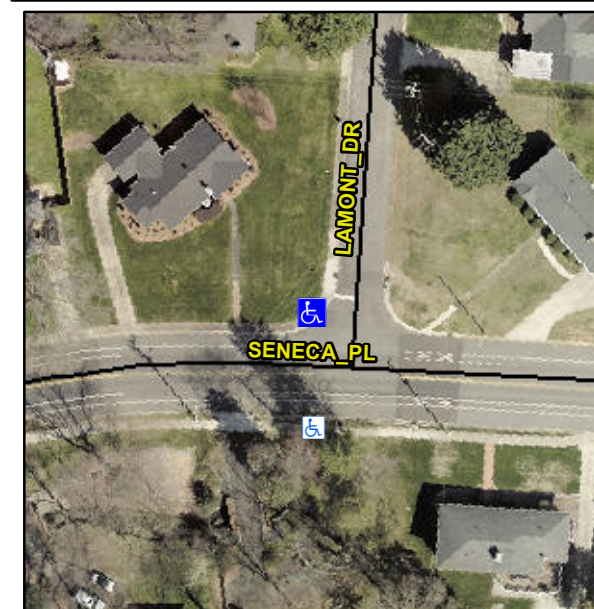
**Not Found, R304.5.1, R304.2.2, R304.5.3**

Compliance	Description	Data	Compliance	Description	Data
N/A	Ramp Length (in)	50.0	No	Ramp Slope (%)	8.8
No	Ramp Width (in)	44.0	No	Ramp XSlope (%)	5.1
N/A	Flare Type LT	N/A	N/A	Flare Type RT	N/A
N/A	Flare Slope LT (%)	N/A	N/A	Flare Slope RT (%)	N/A
N/A	Flare Traversable LT?	N/A	N/A	Flare Traversable RT?	N/A
N/A	Landing Length (in)	N/A	N/A	DWS Provided?	N/A
N/A	Landing Width (in)	N/A	N/A	DWS Contrast?	N/A
N/A	Landing Slope (%)	N/A	N/A	DWS Length (in)	N/A
N/A	Landing X Slope (%)	N/A	N/A	DWS Full Width?	N/A
N/A	Landing Curb? (Y/N)	N/A	N/A	DWS Offset (in)	N/A
N/A	Shared Landing?	N/A			
N/A	Gutter Ponding?	N/A	N/A	Gutter Slope (%)	N/A
N/A	Gutter Lip Ht (in)	N/A	N/A	Gutter X Slope (%)	N/A
N/A	Painted X Walk1?	No	N/A	Painted X Walk2?	No
	X Walk 1 Direction	To S		X Walk 2 Direction	To E
N/A	X Walk 1 Width (in)	N/A	N/A	X Walk 2 Width (in)	N/A
	X Walk 1 Slope (%)	1.5		X Walk 2 Slope (%)	2.8
	X Walk 1 X Slope (%)	2.7		X Walk 2 X Slope (%)	2.9

N/A	Ramp inside XWalk1?	N/A	N/A	Ramp inside XWalk2?	N/A
	Road Slope (%)	4.3	N/A	Clear Space?	N/A
	Road X Slope (%)	0.7	N/A	Clear Space to XWalk (in)	N/A
N/A	Any Obstructions?	N/A	N/A	Storm Grate/Utility Hazard?	N/A
	Obstruction Type			Storm Grate/Utility Type	
		N/A			N/A
			Yes	Surface Condition? (G/P)	Good

**Remove & Replace Curb Ramp With Two New Directional Ramps or Equivalent.**
