Access Compliance Report

Public Rights-of-Way

(Curb Ramps)

Intersection ID: 50605	Main Street: DENBUR_DR	Cross Street: RHODORA_RD	Location: NW
ADA ID: 01C2411FF5FF	Ramp Type: Perp	Initial Pass/Fail: Fail	Overall Compliance: No
Codes/Mitigation Info/Possible Solution		Field Measurements/Component Compliance	
		Severity Score: 10

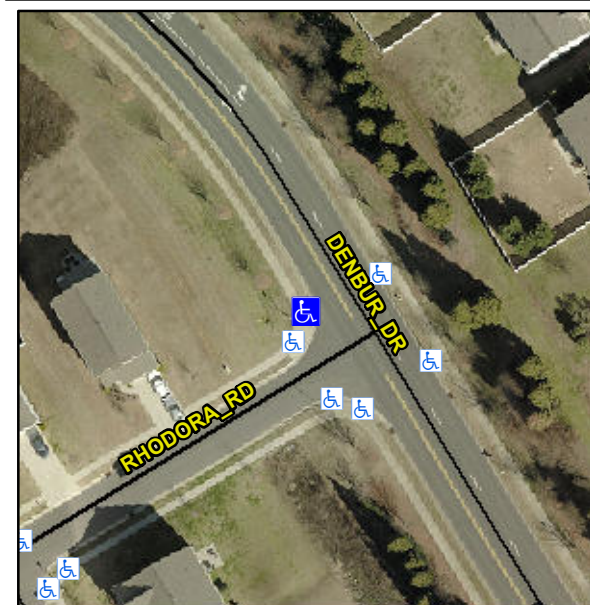
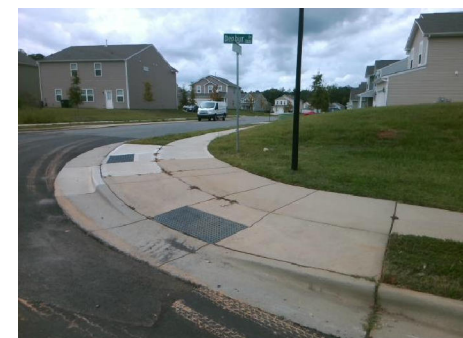
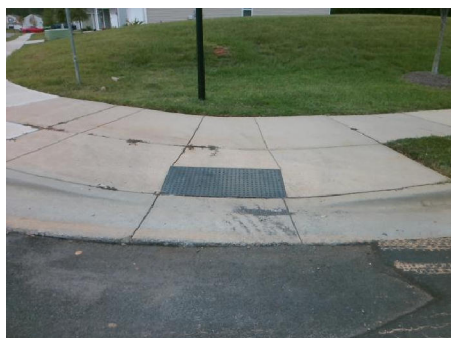
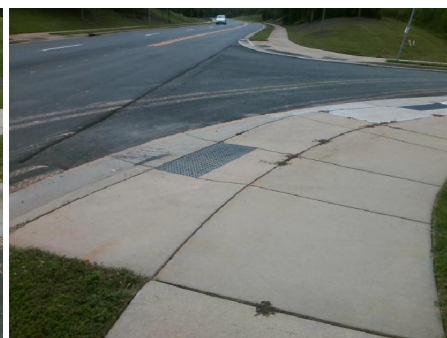
Not Found, R304.5.1

Compliance	Description	Data	Compliance	Description	Data
N/A	Ramp Length (in)	47.5	Yes	Ramp Slope (%)	6.7
No	Ramp Width (in)	40.5	Yes	Ramp XSlope (%)	2.5
N/A	Flare Type LT	N/A	N/A	Flare Type RT	N/A
N/A	Flare Slope LT (%)	N/A	N/A	Flare Slope RT (%)	N/A
N/A	Flare Traversable LT?	N/A	N/A	Flare Traversable RT?	N/A
N/A	Landing Length (in)	N/A	N/A	DWS Provided?	N/A
N/A	Landing Width (in)	N/A	N/A	DWS Contrast?	N/A
N/A	Landing Slope (%)	N/A	N/A	DWS Length (in)	N/A
N/A	Landing X Slope (%)	N/A	N/A	DWS Full Width?	N/A
N/A	Landing Curb? (Y/N)	N/A	N/A	DWS Offset (in)	N/A
N/A	Shared Landing?	N/A			
N/A	Gutter Ponding?	N/A	N/A	Gutter Slope (%)	N/A
N/A	Gutter Lip Ht (in)	N/A	N/A	Gutter X Slope (%)	N/A
N/A	Painted X Walk1?	No	N/A	Painted X Walk2?	N/A
	X Walk 1 Direction	To E		X Walk 2 Direction	N/A
N/A	X Walk 1 Width (in)	N/A	N/A	X Walk 2 Width (in)	N/A
	X Walk 1 Slope (%)	6.4		X Walk 2 Slope (%)	N/A
	X Walk 1 X Slope (%)	4.7		X Walk 2 X Slope (%)	N/A

N/A	Ramp inside XWalk1?	N/A	N/A	Ramp inside XWalk2?	N/A
	Road Slope (%)	N/A	N/A	Clear Space?	N/A
	Road X Slope (%)	N/A	N/A	Clear Space to XWalk (in)	N/A
N/A	Any Obstructions?	N/A	N/A	Storm Grate/Utility Hazard?	N/A
	Obstruction Type			Storm Grate/Utility Type	
		N/A			N/A
			Yes	Surface Condition? (G/P)	Good

Possible Solutions:

Remove & Replace Entire Ramp.

Total Cost: \$ 1850.00
