Access Compliance Report

Public Rights-of-Way

(Curb Ramps)

| Intersection ID: 2956 | Main Street: COTTAGE_OAKS_DR | Cross Street: JOHNSTON MILL CT | Location: NE |

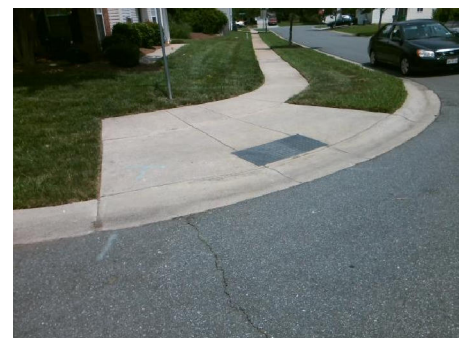
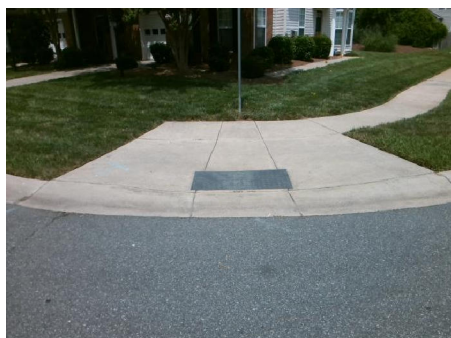
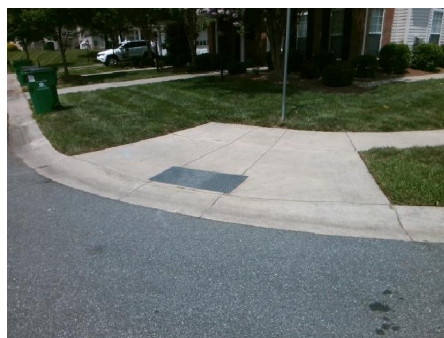
| ADA ID: 01C4029732D9 | Ramp Type: BlendTrans1 | Initial Pass/Fail: Pass | Overall Compliance: No |
| Severity Score: 1.25 | | | |

Not Found, R304.5.1, R304.2.1, R304.2.2-Perp, R304.3.2-Para, R304.5.3, R302.7.2, R304.5.4

| Compliance | Description | Data | Compliance | Description | Data |
|---|---|---|---|---|---|
| N/A | Ramp Length (in) | 83.0 | Yes | BlendTrans Slope (%) | 2.0 |
| No | Ramp Width (in) | 45.0 | Yes | BlendTrans XSlope (%) | 0.6 |
| No | Landing Length (in) | N/A | N/A | DWS Provided? | No |
| Yes | Gutter Ponding? | N/A | No | Gutter Slope (%) | N/A |
| No | Gutter Lip Ht (in) | N/A | No | Gutter X Slope (%) | N/A |

Possible Solutions:

Remove & Replace Curb Ramp With Two New Directional Ramps or Equivalent. Remove & Replace Gutter.

Total Cost: \$ 3950.00
