# Access Compliance Report

## Public Rights-of-Way (Curb Ramps)

Intersection ID: 12018	Main Street: S_GRAHAM_ST	Cross Street: W_3RD-4TH_CONNECTOR_ST	Location: N
ADA ID: 01DBAC132E68	Ramp Type: PerpDiag	Initial Pass/Fail: Fail	Overall Compliance: No
			Severity Score: 48.75

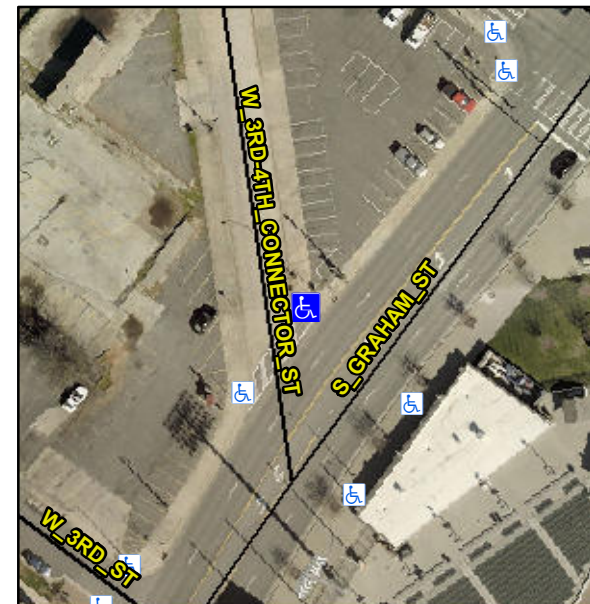
**Not Found, R304.5.1, R304.2.2, R304.5.3**

Compliance	Description	Data	Compliance	Description	Data
N/A	Ramp Length (in)	79.0	No	Ramp Slope (%)	9.3
No	Ramp Width (in)	25.0	No	Ramp XSlope (%)	3.3
N/A	Flare Type LT	N/A	N/A	Flare Type RT	N/A
N/A	Flare Slope LT (%)	N/A	N/A	Flare Slope RT (%)	N/A
N/A	Flare Traversable LT?	N/A	N/A	Flare Traversable RT?	N/A
N/A	Landing Length (in)	N/A	N/A	DWS Provided?	N/A
N/A	Landing Width (in)	N/A	N/A	DWS Contrast?	N/A
N/A	Landing Slope (%)	N/A	N/A	DWS Length (in)	N/A
N/A	Landing X Slope (%)	N/A	N/A	DWS Full Width?	N/A
N/A	Landing Curb? (Y/N)	N/A	N/A	DWS Offset (in)	N/A
N/A	Shared Landing?	N/A			
N/A	Gutter Ponding?	N/A	N/A	Gutter Slope (%)	N/A
N/A	Gutter Lip Ht (in)	N/A	N/A	Gutter X Slope (%)	N/A
N/A	Painted X Walk1?	Yes	N/A	Painted X Walk2?	No
	X Walk 1 Direction	To SW		X Walk 2 Direction	To SE
N/A	X Walk 1 Width (in)	109.0	N/A	X Walk 2 Width (in)	N/A
	X Walk 1 Slope (%)	0.1		X Walk 2 Slope (%)	2.5
	X Walk 1 X Slope (%)	0.9		X Walk 2 X Slope (%)	1.5

N/A	Ramp inside XWalk1?	Yes	N/A	Ramp inside XWalk2?	N/A
	Road Slope (%)	1.0	N/A	Clear Space?	N/A
	Road X Slope (%)	3.1	N/A	Clear Space to XWalk (in)	N/A
N/A	Any Obstructions?	N/A	N/A	Storm Grate/Utility Hazard?	N/A
	Obstruction Type			Storm Grate/Utility Type	
		N/A			N/A
			Yes	Surface Condition? (G/P)	Good

**Remove & Replace Curb Ramp With Two New Directional Ramps or Equivalent.**
