Access Compliance Report

Public Rights-of-Way

(Curb Ramps)

Intersection ID: 44011	Main Street: AVONHURST_LN	Cross Street: BRADWELL_DR	Location: S
ADA ID: 01DBFF8B8604	Ramp Type: PerpDiag	Initial Pass/Fail: Fail	Overall Compliance: No
		Severity Score: 8.75

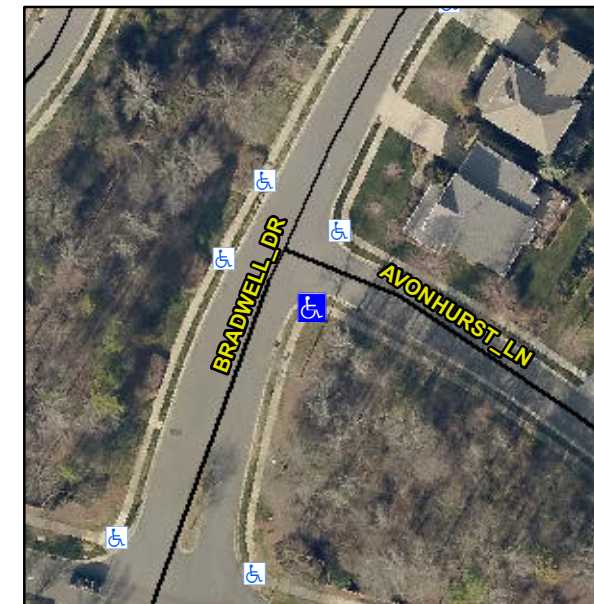
Compliance	Description	Data	Compliance	Description	Data
N/A	Ramp Length (in)	51.0	Yes	Ramp Slope (%)	7.4
No	Ramp Width (in)	36.0	Yes	Ramp XSlope (%)	0.3
N/A	Flare Type LT	N/A	N/A	Flare Type RT	N/A
N/A	Flare Slope LT (%)	N/A	N/A	Flare Slope RT (%)	N/A
N/A	Flare Traversable LT?	N/A	N/A	Flare Traversable RT?	N/A
N/A	Landing Length (in)	N/A	N/A	DWS Provided?	N/A
N/A	Landing Width (in)	N/A	N/A	DWS Contrast?	N/A
N/A	Landing Slope (%)	N/A	N/A	DWS Length (in)	N/A
N/A	Landing X Slope (%)	N/A	N/A	DWS Full Width?	N/A
N/A	Landing Curb? (Y/N)	N/A	N/A	DWS Offset (in)	N/A
N/A	Shared Landing?	N/A			
N/A	Gutter Ponding?	N/A	N/A	Gutter Slope (%)	N/A
N/A	Gutter Lip Ht (in)	N/A	N/A	Gutter X Slope (%)	N/A
N/A	Painted X Walk1?	No	N/A	Painted X Walk2?	No
	X Walk 1 Direction	To NE		X Walk 2 Direction	To NW
N/A	X Walk 1 Width (in)	N/A	N/A	X Walk 2 Width (in)	N/A
	X Walk 1 Slope (%)	3.1		X Walk 2 Slope (%)	1.4
	X Walk 1 X Slope (%)	1.4		X Walk 2 X Slope (%)	3.6

N/A	Ramp inside XWalk1?	N/A	N/A	Ramp inside XWalk2?	N/A
	Road Slope (%)	0.8	N/A	Clear Space?	N/A
	Road X Slope (%)	3.0	N/A	Clear Space to XWalk (in)	N/A
N/A	Any Obstructions?	N/A	N/A	Storm Grate/Utility Hazard?	N/A
	Obstruction Type			Storm Grate/Utility Type	
		N/A			N/A
		Yes		Surface Condition? (G/P)	Good

Possible Solutions:

Remove & Replace Curb Ramp With Two New Directional Ramps or Equivalent.

R304.5.1
