Access Compliance Report Public Rights-of-Way (Curb Ramps)

Intersection ID: 13546 Main Street: N_SHARON_AMITY_RD Cross Street: TARRYWOOD_LN Location: Ε **Overall Compliance: No** ADA ID: 01E6C7E4B71B Ramp Type: Perp Initial Pass/Fail: Fail **Severity Score:** 25

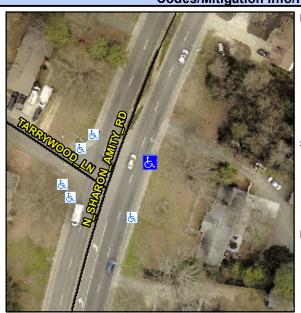
Field Measurements/Component Compliance							
Comp	Data	Comp	liance Description	Data			
N/A	Ramp Length (in)	60.0	No	Ramp Slope (%)	12.8		
Yes	Ramp Width (in)	70.0	Yes	Ramp XSlope (%)	1.0		
N/A	Flare Type LT	N/A	N/A	Flare Type RT	N/A		
N/A	Flare Slope LT (%)	N/A	N/A	Flare Slope RT (%)	N/A		
N/A	Flare Traversable LT?	N/A	N/A	Flare Traversable RT?	N/A		
N/A	Landing Length (in)	N/A	N/A	DWS Provided?	N/A		
N/A	Landing Width (in)	N/A	N/A	DWS Contrast?	N/A		
N/A	Landing Slope (%)	N/A	N/A	DWS Length (in)	N/A		
N/A	Landing X Slope (%)	N/A	N/A	DWS Full Width?	N/A		
N/A	Landing Curb? (Y/N)	N/A	N/A	DWS Offset (in)	N/A		
N/A	Shared Landing?	N/A					
N/A	Gutter Ponding?	N/A	N/A	Gutter Slope (%)	N/A		
N/A	Gutter Lip Ht (in)	N/A	N/A	Gutter X Slope (%)	N/A		
N/A	Painted X Walk1?	No	N/A	Painted X Walk2?	N/A		
	X Walk 1 Direction	To NW		X Walk 2 Direction	N/A		
N/A	X Walk 1 Width (in)	N/A	N/A	X Walk 2 Width (in)	N/A		
	X Walk 1 Slope (%)	3.7		X Walk 2 Slope (%)	N/A

100	Possible Solutions:
The state of the s	Remove & Replace Entire Ramp.
e e	Surveyor Notes:
The state of the s	N/A
-	PROW/ADA:
The state of the s	R304.2.2
