Access Compliance Report

Public Rights-of-Way

(Curb Ramps)

Intersection ID: 3776	Main Street: CANTLE_DR	Cross Street: NETTLE_DR	Location: NW
ADA ID: 01EC804D93D0	Ramp Type: Perp	Initial Pass/Fail: Pass	Overall Compliance: No
Severity Score: 0.25			
Codes/Mitigation Info/Possible Solution		Field Measurements/Component Compliance

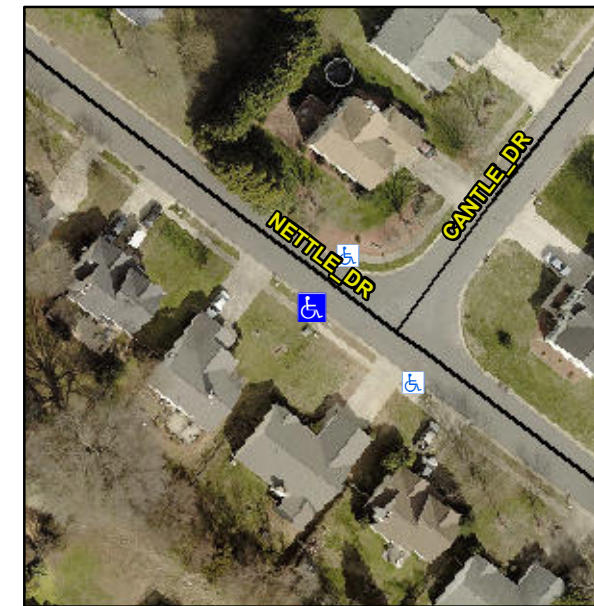
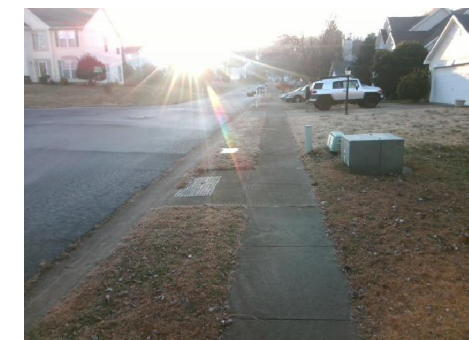
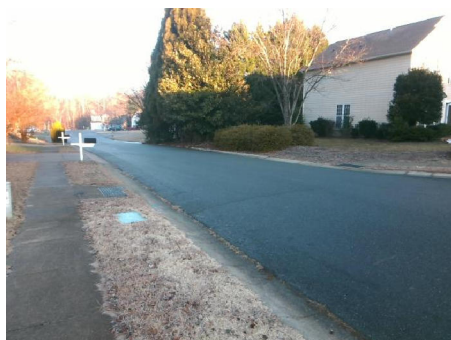
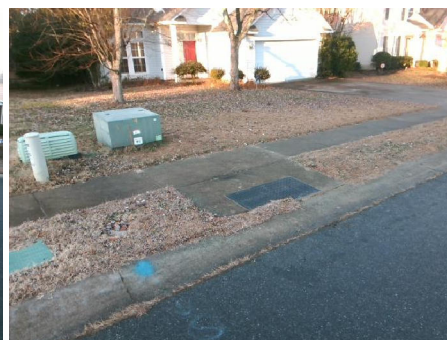
Not Found, R304.5.3, R304.2.1

Compliance	Description	Data	Compliance	Description	Data
N/A	Ramp Length (in)	48.5	Yes	Ramp Slope (%)	6.9
Yes	Ramp Width (in)	48.5	No	Ramp XSlope (%)	2.6
N/A	Flare Type LT	Sloped	N/A	Flare Type RT	N/A
N/A	Flare Slope LT (%)	2.5	Yes	Flare Slope RT (%)	1.2
N/A	Flare Traversable LT?	Yes	N/A	Flare Traversable RT?	Yes
No	Landing Length (in)	46.0	Yes	DWS Provided?	Yes
Yes	Landing Width (in)	48.0	Yes	DWS Contrast?	Yes
Yes	Landing Slope (%)	0.6	Yes	DWS Length (in)	24.0
Yes	Landing X Slope (%)	1.4	Yes	DWS Full Width?	Yes
N/A	Landing Curb? (Y/N)	No	Yes	DWS Offset (in)	1.5
N/A	Shared Landing?	No			
Yes	Gutter Ponding?	No	Yes	Gutter Slope (%)	1.5
Yes	Gutter Lip Ht (in)	0.0	No	Gutter X Slope (%)	2.4
N/A	Painted X Walk1?	No	N/A	Painted X Walk2?	N/A
	X Walk 1 Direction	To NE		X Walk 2 Direction	N/A
N/A	X Walk 1 Width (in)	N/A	N/A	X Walk 2 Width (in)	N/A
	X Walk 1 Slope (%)	3.4		X Walk 2 Slope (%)	N/A
	X Walk 1 X Slope (%)	2.1		X Walk 2 X Slope (%)	N/A

N/A	Ramp inside XWalk1?	N/A	N/A	Ramp inside XWalk2?	N/A
	Road Slope (%)	N/A	N/A	Clear Space?	Yes
	Road X Slope (%)	N/A	N/A	Clear Space to XWalk (in)	N/A
Yes	Any Obstructions?	No	Yes	Storm Grate/Utility Hazard?	No
	Obstruction Type			Storm Grate/Utility Type	
		N/A			N/A
			Yes	Surface Condition? (G/P)	Good

Possible Solutions:

**Remove & Replace Entire Ramp.
Remove & Replace Gutter.**
