# Access Compliance Report

## Public Rights-of-Way

### (Curb Ramps)

| Intersection ID: 42701 | Main Street: SHARON_VIEW_RD | Cross Street: COLEY VIEW CT | Location: S |

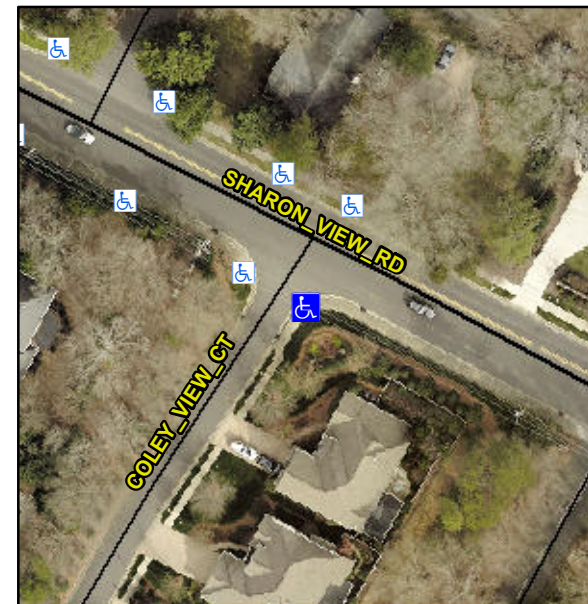
| ADA ID: 01EEC86E043B | Ramp Type: PerpDiag | Initial Pass/Fail: Fail | Overall Compliance: No |

| Severity Score: 13.75 | | | |

**Not Found, R304.2.2, R304.5.3**

| Compliance | Description | Data | Compliance | Description | Data |
|---|---|---|---|---|---|
| N/A | Ramp Length (in) | 28.0 | No | Ramp Slope (%) | 8.7 |
| Yes | Ramp Width (in) | 48.0 | No | Ramp XSlope (%) | 2.9 |

**Remove & Replace Curb Ramp With Two New Directional Ramps or Equivalent.**
