Access Compliance Report Public Rights-of-Way (Curb Ramps)

Intersection ID: 1002587	D: 10025871 Main Street: ELEVATION_POINT_DR			Cross Street: N/A				NW
ADA ID: 01F9875AEC21	75AEC21 Ramp Type: Perp			Initial Pass/Fail: Pass Overall Compliance: No			o Severity Score:	0.25
Codes/Mitigation Info/Possible Solution			Field Measurements/Component Compliance					
Possible Solutions:		_	Compliance Description Data Compliance			liance Description	Data	
	and DR	Remove & Replace Entire Ramp	N/A	Ramp Length (in)	95.0	Yes	Ramp Slope (%)	7.2
	ST SOUTH		Yes	Ramp Width (in)	59.0	No	Ramp XSlope (%)	3.1
Le Colleve	No.		Yes	Flare Type LCurbed_NoWal	kSurface	Yes	Flare Type RT	N/A
TT -	A second the		Yes	Flare Slope LT (%)	N/A	N/A	Flare Slope RT (%)	N/A
I DE E	and a contraction		N/A	Flare Traversable LT?	No	N/A	Flare Traversable RT?	No
A BEALT	5.		Yes	Landing Length (in)	96.0	Yes	DWS Provided?	Yes
Contraction of the second s		Surveyor Notes:	Yes	Landing Width (in)	73.0	Yes	DWS Contrast?	Yes

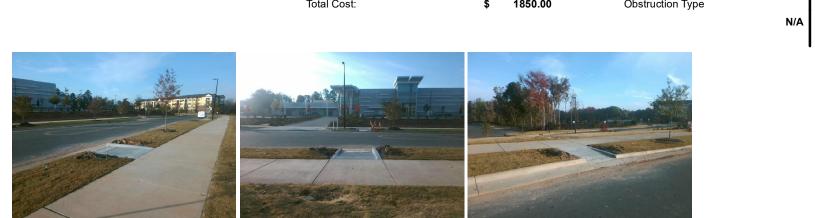
the set	OINT DR	N/A	Yes	Landing Slope (%)	1.4	Yes	DWS Length (in)	24.0
TUEVATION	A REAL PROPERTY AND		Yes	Landing X Slope (%)	1.2	Yes	DWS Full Width?	Yes

6.	6.		N/A	Landing Curb? (Y/N)	No	Yes	DWS Offset (in)	0.0
the second s	6		N/A	Shared Landing?	No			
A PLANT	A KITTIN	PROW/ADA:	Yes	Gutter Ponding?	No	Yes	Gutter Slope (%)	1.7
Ann the second		Not Found, R304.5.3	Yes	Gutter Lip Ht (in)	0.0	Yes	Gutter X Slope (%)	0.2
	AN A		N/A	Painted X Walk1?	No	N/A	Painted X Walk2?	N/A
				X Walk 1 Direction	To S		X Walk 2 Direction	N/A
TUILLY SAME			N/A	X Walk 1 Width (in)	N/A	N/A	X Walk 2 Width (in)	N/A
Street 1 Name	ELEVATION POINT DR			X Walk 1 Slope (%)	3.6		X Walk 2 Slope (%)	N/A
Stop Condition-Street 2	None			X Walk 1 X Slope (%)	0.1		X Walk 2 X Slope (%)	N/A
Street 2 Name	N/A		N/A	Ramp inside XWalk1?	N/A	N/A	Ramp inside XWalk2?	N/A
Stop Condition-Street 1	N/A			Road Slope (%)	N/A	N/A	Clear Space?	Yes
				Road X Slope (%)	N/A	N/A	Clear Space to XWalk (in)	N/A
			Yes	Any Obstructions?	No	Yes	Storm Grate/Utility Hazard?	No
		Total Cost: \$ 1	850.00	Obstruction Type			Storm Grate/Utility Type
