Access Compliance Report

Public Rights-of-Way

(Curb Ramps)

Intersection ID: N/A	Main Street: GROVER_RD	Cross Street: N/A	Location: NE
ADA ID: 0204183028C0	Ramp Type: Perp	Initial Pass/Fail: Pass	Overall Compliance: No
Codes/Mitigation Info/Possible Solution		Field Measurements/Component Compliance	
Severity Score: 0.25

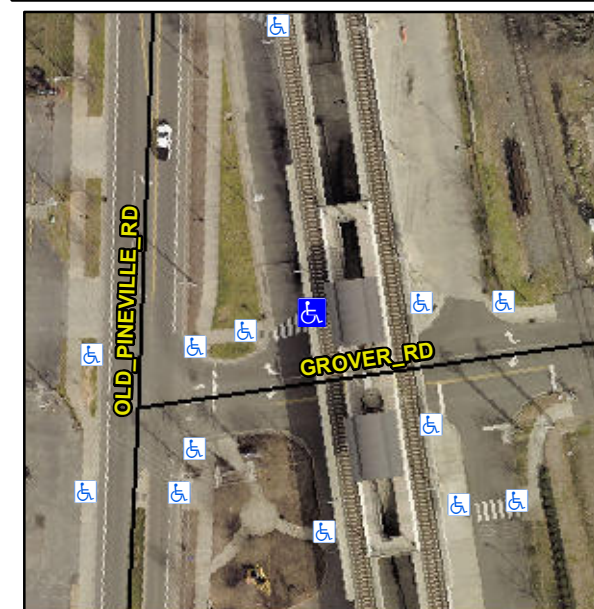
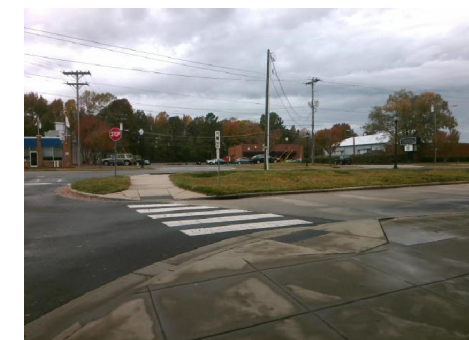
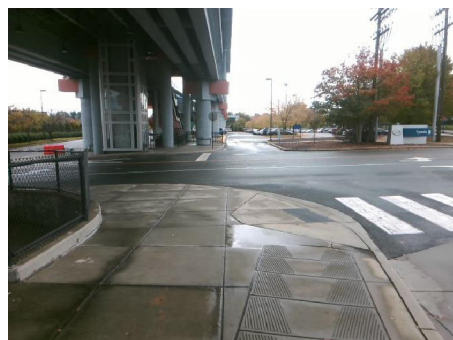
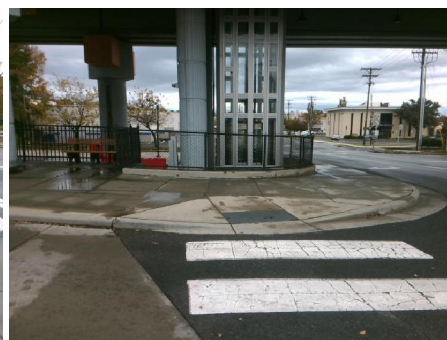
Compliance	Description	Data	Compliance	Description	Data
N/A	Ramp Length (in)	73.0	Yes	Ramp Slope (%)	5.3
Yes	Ramp Width (in)	48.0	No	Ramp XSlope (%)	2.5
N/A	Flare Type LT	Sloped	N/A	Flare Type RT	N/A
N/A	Flare Slope LT (%)	6.4	Yes	Flare Slope RT (%)	1.2
N/A	Flare Traversable LT?	Yes	N/A	Flare Traversable RT?	Yes
Yes	Landing Length (in)	48.5	Yes	DWS Provided?	Yes
Yes	Landing Width (in)	48.0	Yes	DWS Contrast?	Yes
Yes	Landing Slope (%)	1.5	Yes	DWS Length (in)	24.0
No	Landing X Slope (%)	3.9	Yes	DWS Full Width?	Yes
N/A	Landing Curb? (Y/N)	No	Yes	DWS Offset (in)	2.0
N/A	Shared Landing?	No			
Yes	Gutter Ponding?	No	Yes	Gutter Slope (%)	1.5
Yes	Gutter Lip Ht (in)	0.0	Yes	Gutter X Slope (%)	1.6
N/A	Painted X Walk1?	Yes	N/A	Painted X Walk2?	N/A
	X Walk 1 Direction	To W		X Walk 2 Direction	N/A
N/A	X Walk 1 Width (in)	120.0	N/A	X Walk 2 Width (in)	N/A
	X Walk 1 Slope (%)	2.2		X Walk 2 Slope (%)	N/A
	X Walk 1 X Slope (%)	0.8		X Walk 2 X Slope (%)	N/A

Yes	Ramp inside XWalk1?	Yes	N/A	Ramp inside XWalk2?	N/A
	Road Slope (%)	N/A	N/A	Clear Space?	Yes
	Road X Slope (%)	N/A	N/A	Clear Space to XWalk (in)	N/A
Yes	Any Obstructions?	No	Yes	Storm Grate/Utility Hazard?	No
	Obstruction Type			Storm Grate/Utility Type	
		N/A			N/A
			Yes	Surface Condition? (G/P)	Good

Possible Solutions:

Remove & Replace Entire Ramp.

R304.5.3

Total Cost: \$ 1850.00
