Access Compliance Report Public Rights-of-Way (Curb Ramps)

Intersection ID: 31654Main Street: JAMES_RDCross Street: WILLIAM_REYNOLDS_DRLocation:SWADA ID: 02242DF616D5Ramp Type: PerpInitial Pass/Fail: FailOverall Compliance: NoSeverity Score: 21.25

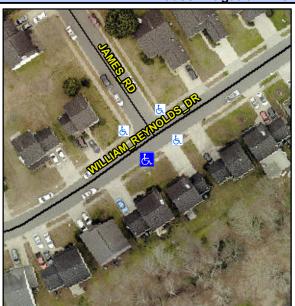
Field Measurements/Component Compliance									
Compliance Description		Data	Compli	ance	Description	Data			
N/A	Ramp Length (in)	48.0	No	Ramp	Slope (%)	10.5			
No	Ramp Width (in)	47.5	Yes	Ramp	XSlope (%)	1.6			
N/A	Flare Type LT	N/A	N/A	Flare	Type RT	N/A			
N/A	Flare Slope LT (%)	N/A	N/A	Flare	Slope RT (%)	N/A			
N/A	Flare Traversable LT?	N/A	N/A	Flare	Traversable RT?	N/A			
N/A	Landing Length (in)	N/A	N/A	DWS	Provided?	N/A			
N/A	Landing Width (in)	N/A	N/A	DWS	Contrast?	N/A			
N/A	Landing Slope (%)	N/A	N/A	DWS	Length (in)	N/A			
N/A	Landing X Slope (%)	N/A	N/A	DWS	Full Width?	N/A			
N/A	Landing Curb? (Y/N)	N/A	N/A	DWS	Offset (in)	N/A			
N/A	Shared Landing?	N/A							
N/A	Gutter Ponding?	N/A	N/A	Gutte	r Slope (%)	N/A			
N/A	Gutter Lip Ht (in)	N/A	N/A	Gutte	r X Slope (%)	N/A			
N/A	Painted X Walk1?	No	N/A	Paint	ed X Walk2?	N/A			
	X Walk 1 Direction	To N		X Wa	lk 2 Direction	N/A			
N/A	X Walk 1 Width (in)	N/A	N/A	X Wa	lk 2 Width (in)	N/A

X Walk 1 Slope (%)	3.2		X Wa	lk 2 Slope (%)	N/A			
	X Walk 1 X Slope (%)	3.4		X Wa	lk 2 X Slope (%)	N/A			
N/A	Ramp inside XWalk1?	N/A	N/A	Ramp	inside XWalk2?	N/A			
	Road Slope (%)	N/A	N/A	Clear	Space?	N/A			
	Road X Slope (%)	N/A	N/A	Clear	Space to XWalk (in)	N/A			
N/A	Any Obstructions?	N/A	N/A	Storn	n Grate/Utility Hazard?	N/A			
	Obstruction Type			Storn	n Grate/Utility Type				
		N/A				N/A

1	Possible Solutions:	Co
1	Remove & Replace Entire Ramp.	N/A
-		No
4		N/A
		N/A
		N/A
d		N/A
ř	Surveyor Notes:	N/A
b	N/A	N/A
•		N/A
		N/A
		N/A
No. of London	PROW/ADA:	N/A
Sec. 30	Not Found, R304.5.1, R304.2.2	N/A
455		N/A
The Party of the P		N/J
		N//
