Access Compliance Report Public Rights-of-Way (Curb Ramps)

Intersection ID: 27177Main Street: PROVIDENCE_RDCross Street: MCKEE_RDLocation:NWADA ID: 0224D88DB43CRamp Type: PerpInitial Pass/Fail: FailOverall Compliance: NoSeverity Score:25

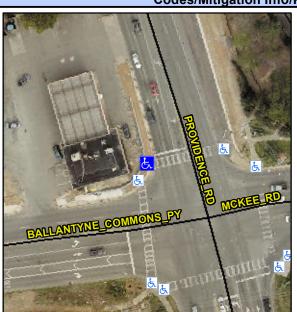
| Comp | liance Description | Data | | pliance Description | Data |
|---|---|---|---|---|---|
| N/A | Ramp Length (in) | 88.0 | No | Ramp Slope (%) | 14.7 |
| Yes | Ramp Width (in) | 49.0 | Yes | Ramp XSlope (%) | 1.9 |

| Total Cost: | \$ 1850.00 |
