# Access Compliance Report

## Public Rights-of-Way

### (Curb Ramps)

| Intersection ID: 13705 | Main Street: CENTRAL_AV | Cross Street: CYRUS_DR | Location: SE |

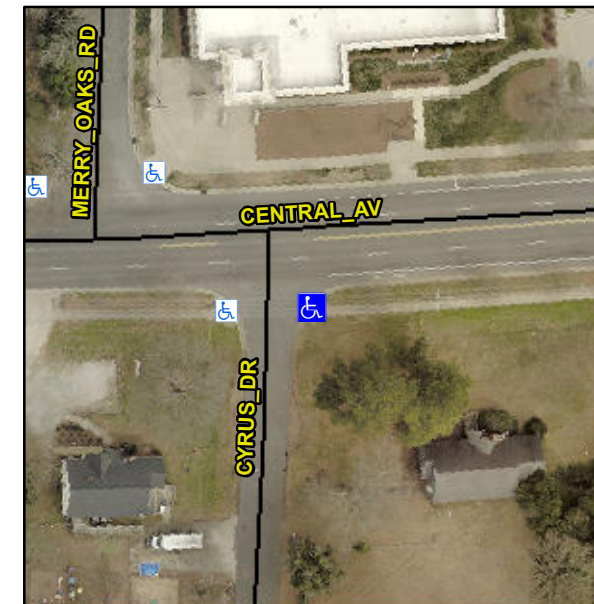
| Severity Score: 22.5 | | | |

**Not Found, R304.5.1, R304.2.2, R304.5.3**

| Compliance | Description | Data | Compliance | Description | Data |
|---|---|---|---|---|---|
| N/A | Ramp Length (in) | 46.0 | No | Ramp Slope (%) | 9.1 |
| No | Ramp Width (in) | 39.0 | No | Ramp XSlope (%) | 2.7 |

**Remove & Replace Entire Ramp.**
