Access Compliance Report

Public Rights-of-Way

(Curb Ramps)

Intersection ID: N/A	Main Street: PERIMETER_PY	Cross Street: N/A	Location: SW
ADA ID: 023AA9BF14EC	Ramp Type: PerpDiag	Initial Pass/Fail: Pass	Overall Compliance: No
		Severity Score: 5

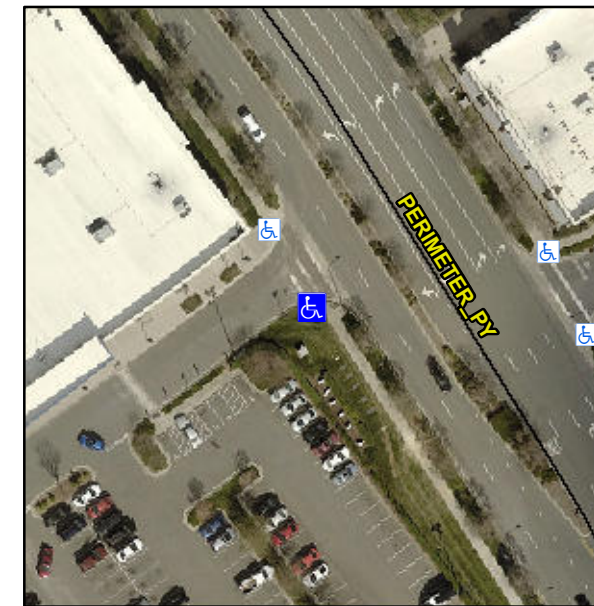
Compliance	Description	Data	Compliance	Description	Data
N/A	Ramp Length (in)	72.0	Yes	Ramp Slope (%)	7.5
Yes	Ramp Width (in)	48.0	Yes	Ramp XSlope (%)	0.4
N/A	Flare Type LT	Sloped	N/A	Flare Type RT	N/A
N/A	Flare Slope LT (%)	7.3	N/A	Flare Slope RT (%)	8.9
N/A	Flare Traversable LT?	No	N/A	Flare Traversable RT?	No
No	Landing Length (in)	30.0	Yes	DWS Provided?	Yes
Yes	Landing Width (in)	48.0	Yes	DWS Contrast?	Yes
No	Landing Slope (%)	3.1	Yes	DWS Length (in)	24.5
Yes	Landing X Slope (%)	0.7	Yes	DWS Full Width?	Yes
N/A	Landing Curb? (Y/N)	No	Yes	DWS Offset (in)	1.0
N/A	Shared Landing?	No			
No	Gutter Ponding?	Yes	No	Gutter Slope (%)	6.6
Yes	Gutter Lip Ht (in)	0.0	Yes	Gutter X Slope (%)	0.7
N/A	Painted X Walk1?	No	N/A	Painted X Walk2?	Yes
	X Walk 1 Direction	To E		X Walk 2 Direction	To N
N/A	X Walk 1 Width (in)	N/A	N/A	X Walk 2 Width (in)	71.0
	X Walk 1 Slope (%)	4.2		X Walk 2 Slope (%)	4.6
	X Walk 1 X Slope (%)	2.9		X Walk 2 X Slope (%)	3.3

N/A	Ramp inside XWalk1?	N/A	Yes	Ramp inside XWalk2?	Yes
	Road Slope (%)	0.0	N/A	Clear Space?	Yes
	Road X Slope (%)	4.3	N/A	Clear Space to XWalk (in)	N/A
Yes	Any Obstructions?	No	Yes	Storm Grate/Utility Hazard?	No
	Obstruction Type			Storm Grate/Utility Type	
		N/A			N/A
			Yes	Surface Condition? (G/P)	Good

**Remove & Replace Landing.
Remove & Replace Gutter.**
