Access Compliance Report

Public Rights-of-Way

(Curb Ramps)

Intersection ID: 10038891	Main Street: STIRLINGSHIRE_CT	Cross Street: N/A	Location: SE
ADA ID: 023D3C76FA10	Ramp Type: Perp	Initial Pass/Fail: Pass	Overall Compliance: No
Codes/Mitigation Info/Possible Solution		Field Measurements/Component Compliance	
Severity Score: 0.25

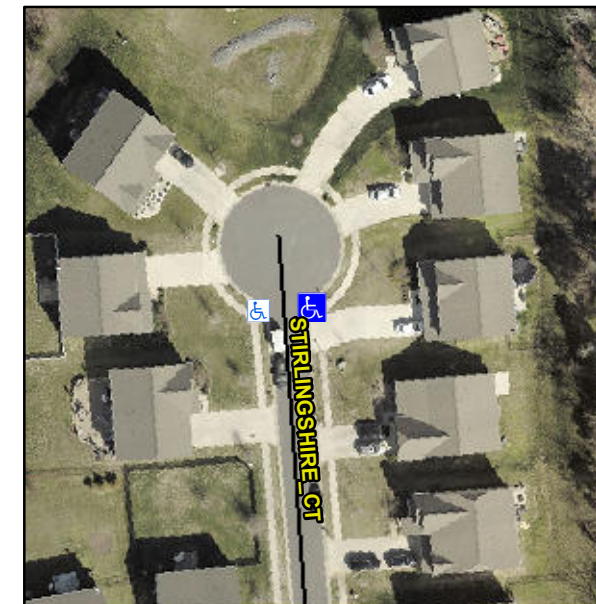
R304.5.3, R304.2.2-Perp, R304.3.2-Para

Compliance	Description	Data	Compliance	Description	Data
N/A	Ramp Length (in)	46.0	Yes	Ramp Slope (%)	6.7
Yes	Ramp Width (in)	48.0	No	Ramp XSlope (%)	2.5
N/A	Flare Type LT	Sloped	N/A	Flare Type RT	N/A
N/A	Flare Slope LT (%)	2.5	Yes	Flare Slope RT (%)	4.2
N/A	Flare Traversable LT?	Yes	N/A	Flare Traversable RT?	Yes
Yes	Landing Length (in)	48.0	Yes	DWS Provided?	Yes
Yes	Landing Width (in)	48.0	Yes	DWS Contrast?	Yes
No	Landing Slope (%)	3.9	Yes	DWS Length (in)	24.0
Yes	Landing X Slope (%)	1.6	Yes	DWS Full Width?	Yes
N/A	Landing Curb? (Y/N)	No	Yes	DWS Offset (in)	2.0
N/A	Shared Landing?	No			
Yes	Gutter Ponding?	No	Yes	Gutter Slope (%)	2.6
Yes	Gutter Lip Ht (in)	0.0	Yes	Gutter X Slope (%)	1.1
N/A	Painted X Walk1?	No	N/A	Painted X Walk2?	N/A
	X Walk 1 Direction	To W		X Walk 2 Direction	N/A
N/A	X Walk 1 Width (in)	N/A	N/A	X Walk 2 Width (in)	N/A
	X Walk 1 Slope (%)	4.9		X Walk 2 Slope (%)	N/A
	X Walk 1 X Slope (%)	1.1		X Walk 2 X Slope (%)	N/A

N/A	Ramp inside XWalk1?	N/A	N/A	Ramp inside XWalk2?	N/A
	Road Slope (%)	N/A	N/A	Clear Space?	Yes
	Road X Slope (%)	N/A	N/A	Clear Space to XWalk (in)	N/A
Yes	Any Obstructions?	No	Yes	Storm Grate/Utility Hazard?	No
	Obstruction Type			Storm Grate/Utility Type	
		N/A			N/A
			Yes	Surface Condition? (G/P)	Good

Possible Solutions:

Remove & Replace Entire Ramp.

Total Cost: \$ 1850.00
