Access Compliance Report

Public Rights-of-Way

(Curb Ramps)

Intersection ID: 9768	Main Street: EASTWAY_DR	Cross Street: THE_PLAZA	Location: SE
ADA ID: 02519E70B7B6	Ramp Type: Perp	Initial Pass/Fail: Fail	Overall Compliance: No
Severity Score: 22.5			
Codes/Mitigation Info/Possible Solution		Field Measurements/Component Compliance

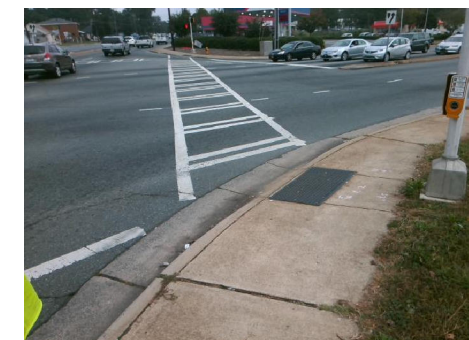
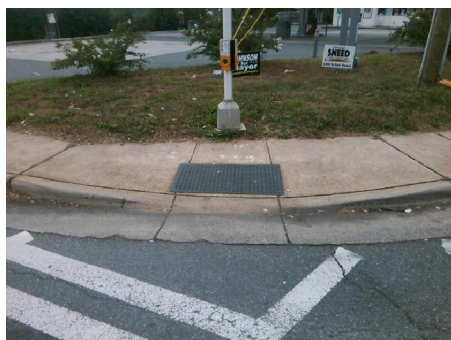
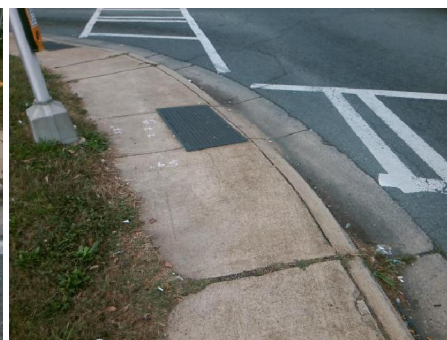
Not Found, R304.5.1, R304.2.2, R304.5.3

Compliance	Description	Data	Compliance	Description	Data
N/A	Ramp Length (in)	59.0	No	Ramp Slope (%)	8.4
No	Ramp Width (in)	37.0	No	Ramp XSlope (%)	2.7
N/A	Flare Type LT	N/A	N/A	Flare Type RT	N/A
N/A	Flare Slope LT (%)	N/A	N/A	Flare Slope RT (%)	N/A
N/A	Flare Traversable LT?	N/A	N/A	Flare Traversable RT?	N/A
N/A	Landing Length (in)	N/A	N/A	DWS Provided?	N/A
N/A	Landing Width (in)	N/A	N/A	DWS Contrast?	N/A
N/A	Landing Slope (%)	N/A	N/A	DWS Length (in)	N/A
N/A	Landing X Slope (%)	N/A	N/A	DWS Full Width?	N/A
N/A	Landing Curb? (Y/N)	N/A	N/A	DWS Offset (in)	N/A
N/A	Shared Landing?	N/A			
N/A	Gutter Ponding?	N/A	N/A	Gutter Slope (%)	N/A
N/A	Gutter Lip Ht (in)	N/A	N/A	Gutter X Slope (%)	N/A
N/A	Painted X Walk1?	Yes	N/A	Painted X Walk2?	N/A
	X Walk 1 Direction	To NE		X Walk 2 Direction	N/A
N/A	X Walk 1 Width (in)	75.5	N/A	X Walk 2 Width (in)	N/A
	X Walk 1 Slope (%)	0.1		X Walk 2 Slope (%)	N/A
	X Walk 1 X Slope (%)	1.5		X Walk 2 X Slope (%)	N/A

N/A	Ramp inside XWalk1?	Yes	N/A	Ramp inside XWalk2?	N/A
	Road Slope (%)	N/A	N/A	Clear Space?	N/A
	Road X Slope (%)	N/A	N/A	Clear Space to XWalk (in)	N/A
N/A	Any Obstructions?	N/A	N/A	Storm Grate/Utility Hazard?	N/A
	Obstruction Type			Storm Grate/Utility Type	
		N/A			N/A
		Yes		Surface Condition? (G/P)	Good

Remove & Replace Entire Ramp.
